B. GEOLOGICAL STUDIES

B.2 INVENTORY OF EXISTING LAND INSTABILITIES

LANDSLIDE 1**Location**

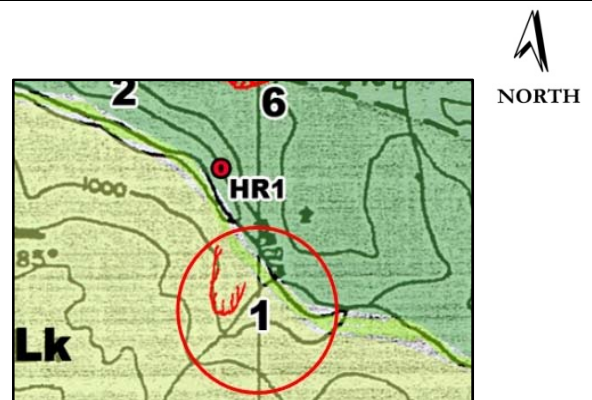
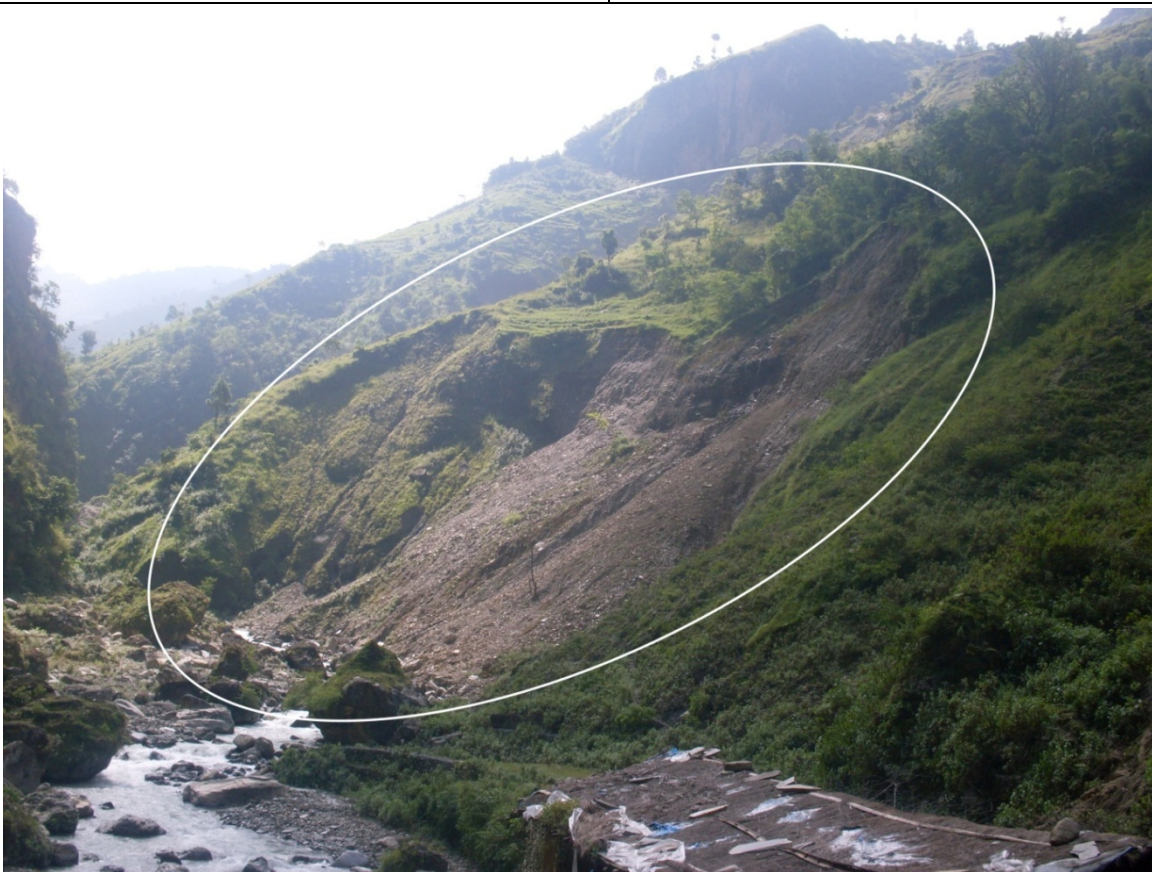
Dhik Gad at road level

Size (m²)	40 × 30
Geomorphology	Moderate to steep slope
Geology	Loose soil mixed with Colluviums
Formation	Lakharpata
Hydrology	Damp
Failure type	Embankment Failure
Scale	Small
Nature	Debris
Dominant mechanism	Loose soil mass, toe cutting
Hazard rating	Very high

- Slope modification
- Gabion wall and jute netting , launching apron with grass vegetation
- Management of drainage, vegetated stone pitching

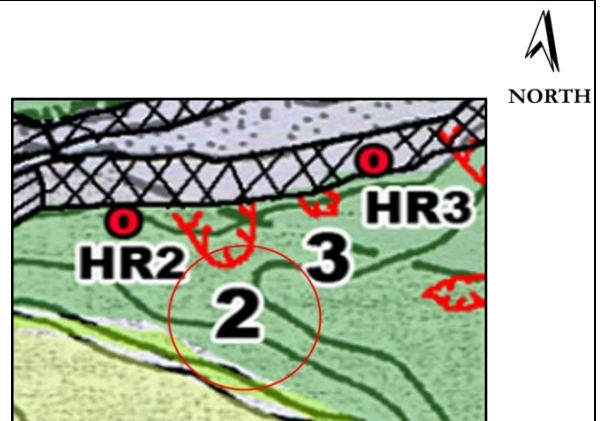
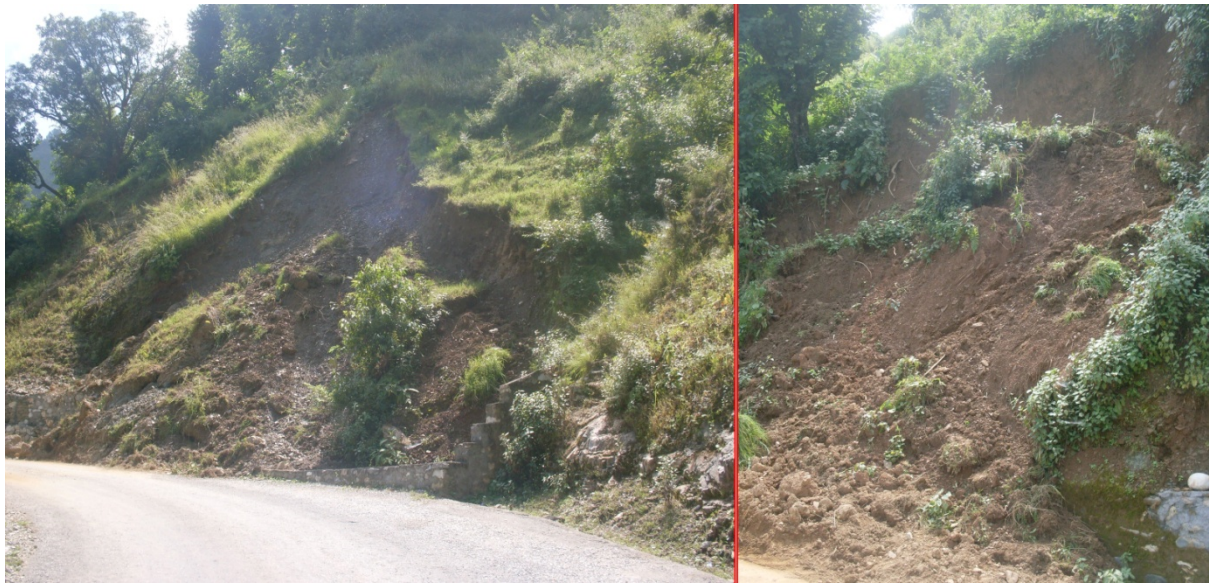
LANDSLIDE 2**Location**

Left bank of Chameliya River (2 landslide)

Size (m²)	8 × 15 20 × 30
Geomorphology	Moderately steep
Geology	Colluvial
Formation	Lakharpata
Hydrology	Wet
Failure type	Collapse
Scale	Small
Nature	Debris
Dominant mechanism	Loose soil mass, road cutting
Hazard rating	Very high

- Gabion wall or Crib wall
- Slope modification (< 30°)
- Grass plantation with jute netting

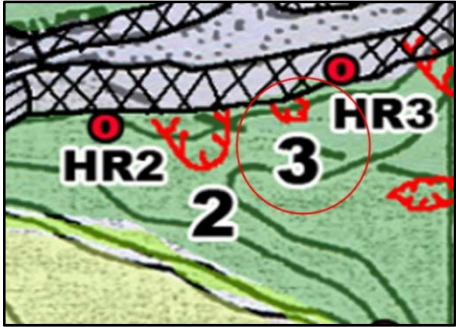
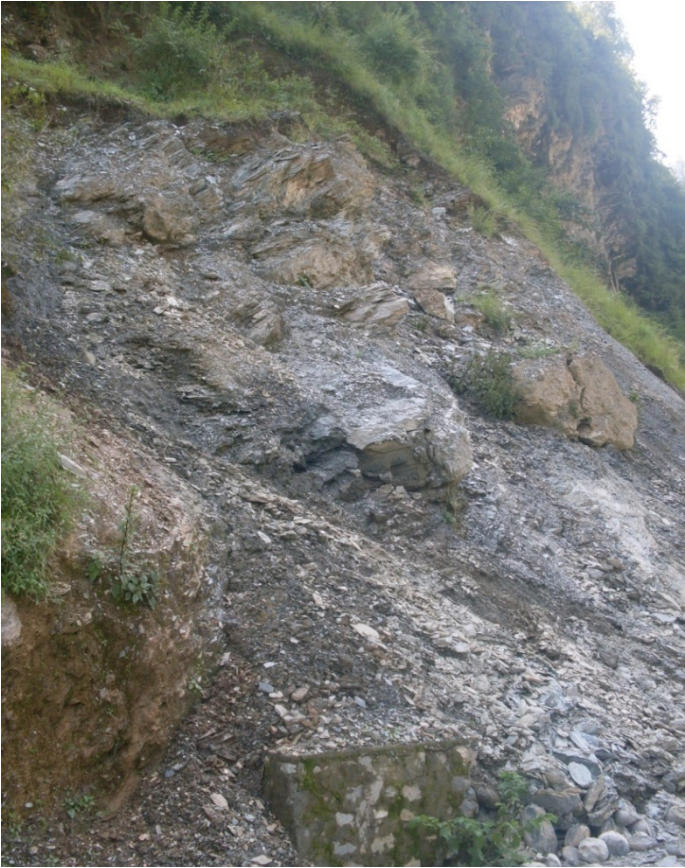
LANDSLIDE 3	
Location	
Left bank of Chameliya at road level near Salsena	
Easting	441167
Northing	3277794
Elevation	738
Characteristics of slide	
Size (m²)	25 × 20
Geomorphology	Moderate slope
Geology	Very weak and crushed phyllite
Formation	Galyang
Hydrology	Dry
Failure type	Rock mass failure
Scale	Small
Nature	Rock
Dominant mechanism	Poor rock mass, road cutting
Hazard rating	Very high

Proposed stabilization measures	
<ul style="list-style-type: none"> • Toe protection with stone masonry • Shotcrete with wire mesh and rock bolts

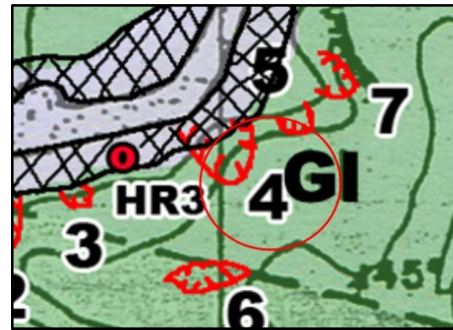
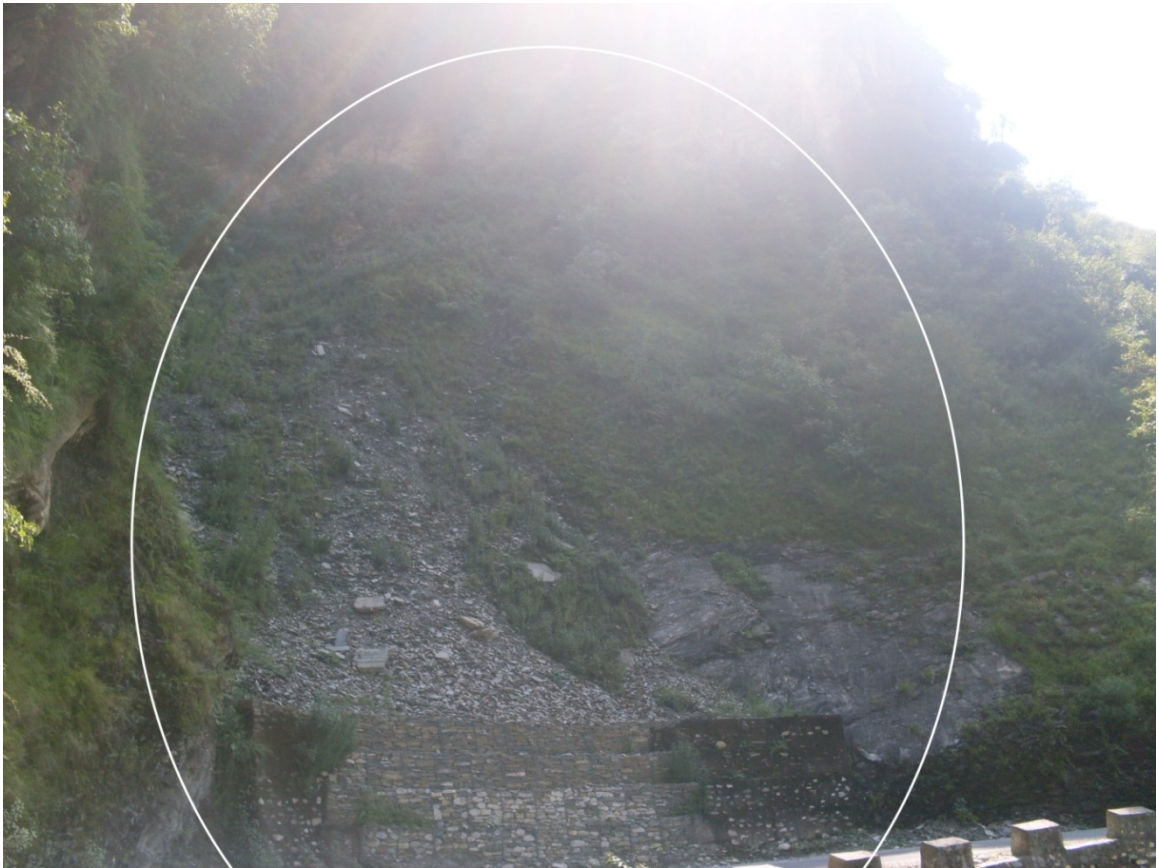
LANDSLIDE 4**Location**

Left bank of Chameliya River

Size (m²)	20 × 15
Geomorphology	Steep slope
Geology	Very weak rock mass in steep slope, seepage
Formation	Galyang
Hydrology	Wet (Seepage)
Failure type	Collapse
Scale	Small
Nature	Debris
Dominant mechanism	Steep slope, loose colluviums
Hazard rating	Very high

- Gabion wall with jute netting grass vegetation

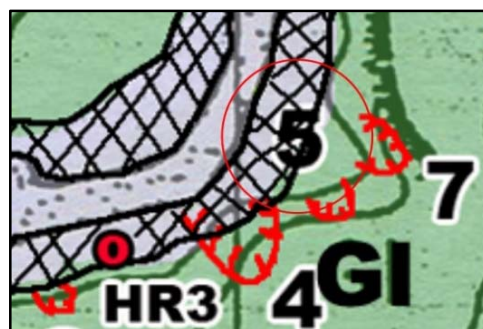
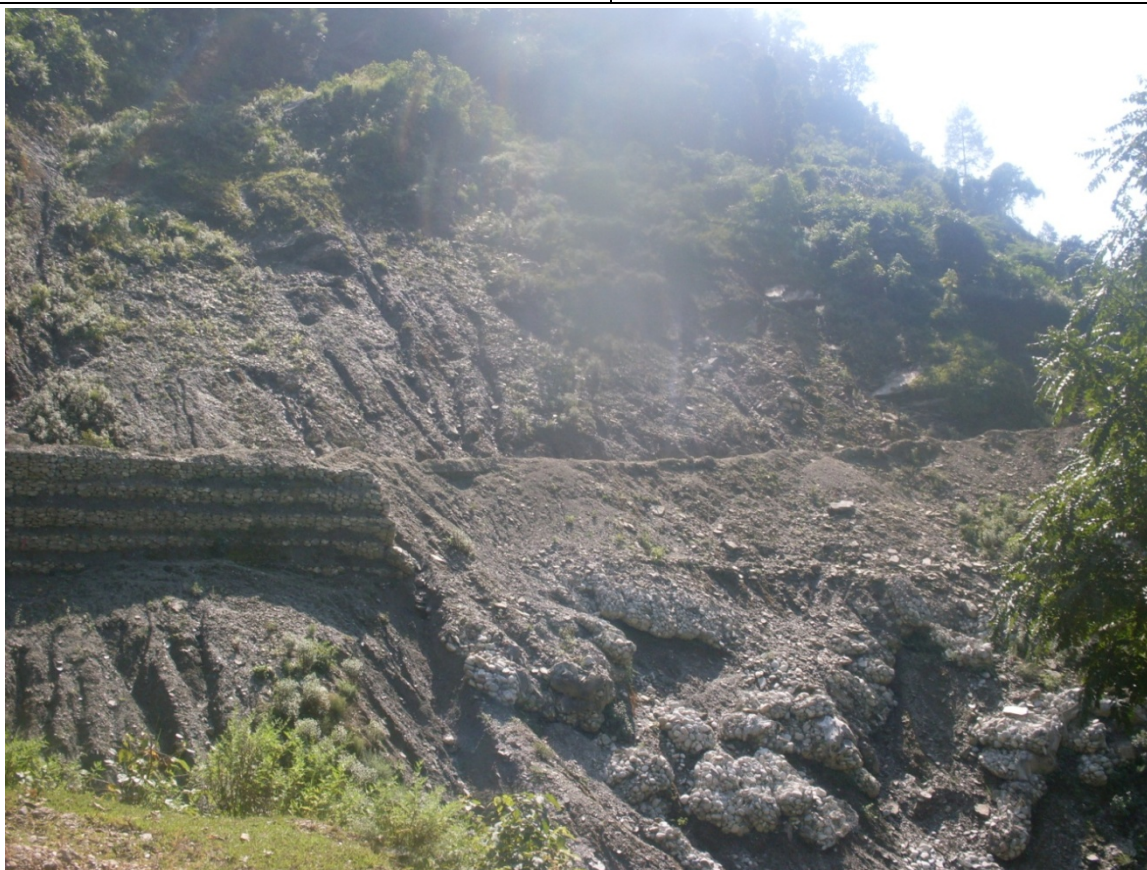
LANDSLIDE 5**Location**

Left bank of Chamtari River

Size (m²)	200 × 200
Geomorphology	Steep slope
Geology	Highly crushed phyllite/slate
Formation	Galyang
Hydrology	Wet
Failure type	Landslide
Scale	Large
Nature	Debris
Dominant mechanism	Steep slope, loose colluviums
Hazard rating	Very high

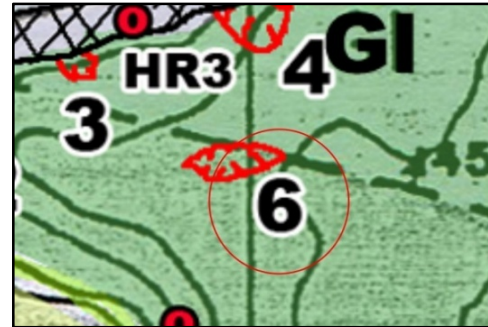
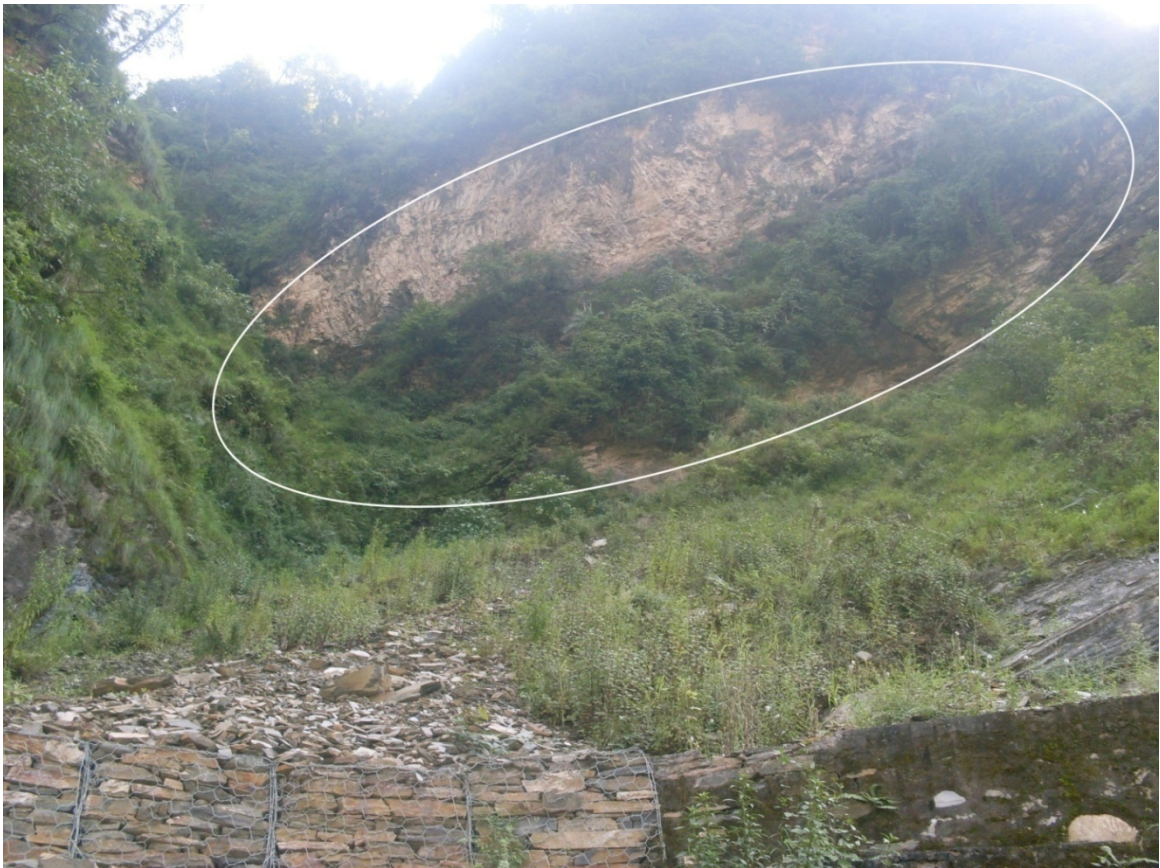
LANDSLIDE 6**Location**

Size (m²)	50 × 25
Geomorphology	Moderate to steep slope
Geology	Highly jointed Rock masses
Formation	Lakharpata
Hydrology	Dry
Failure type	Rock fall
Scale	Small
Nature	Rock
Dominant mechanism	Steep slope, highly jointed rock mass
Hazard rating	Very high

- Shotcreting at the crown
- Gabion wall with grass vegetation

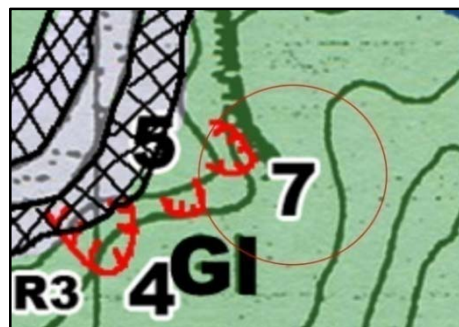
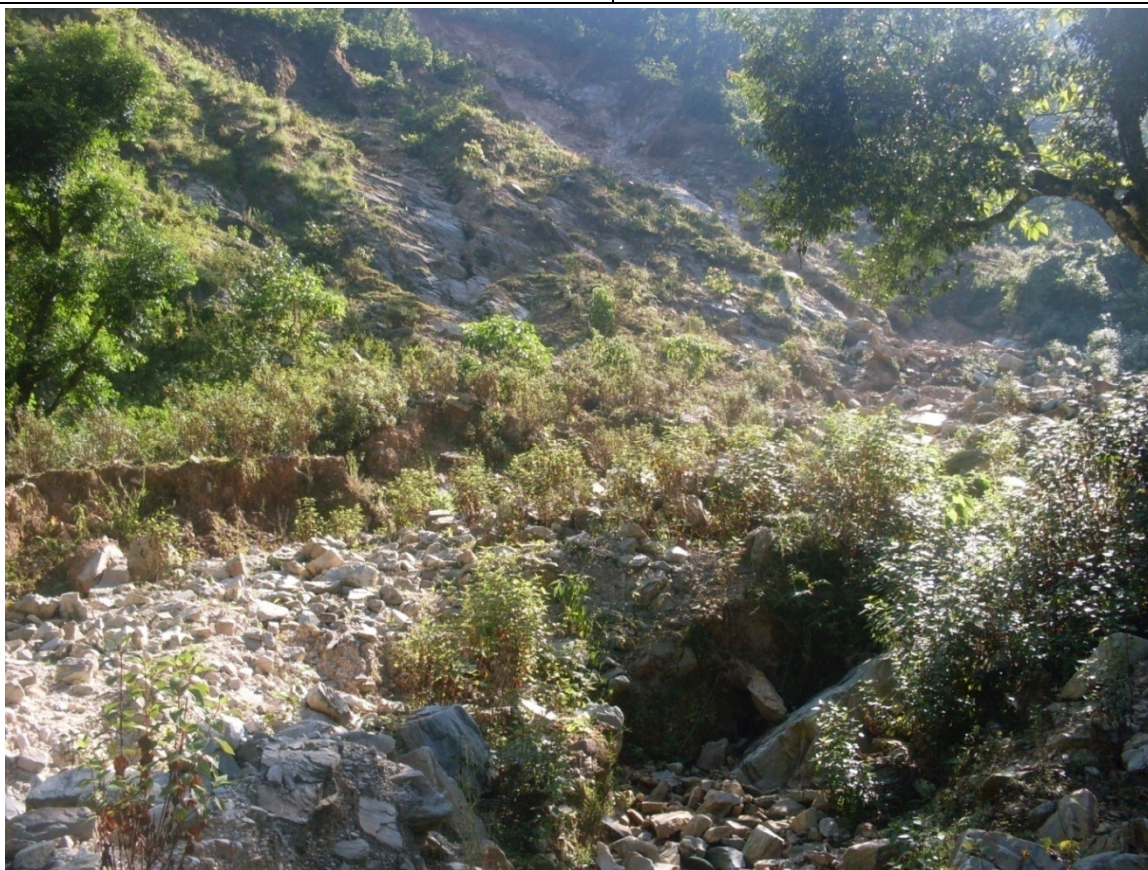
LANDSLIDE 7**Location**

Size (m²)	30 × 40
Geomorphology	Moderate slope
Geology	Loose Colluviums
Formation	Galyang
Hydrology	Dry to damp
Failure type	Landslide
Scale	Small
Nature	Debris
Dominant mechanism	Loose soil
Hazard rating	Very high

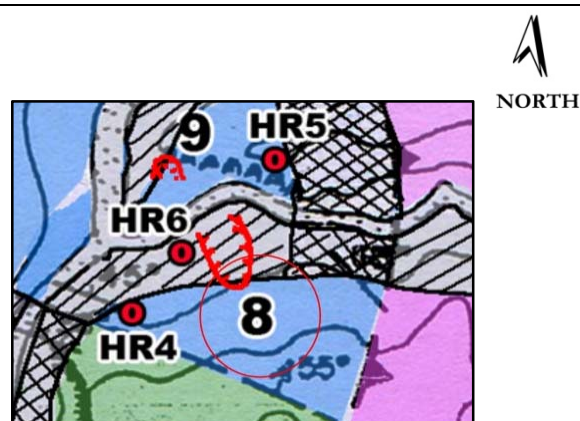
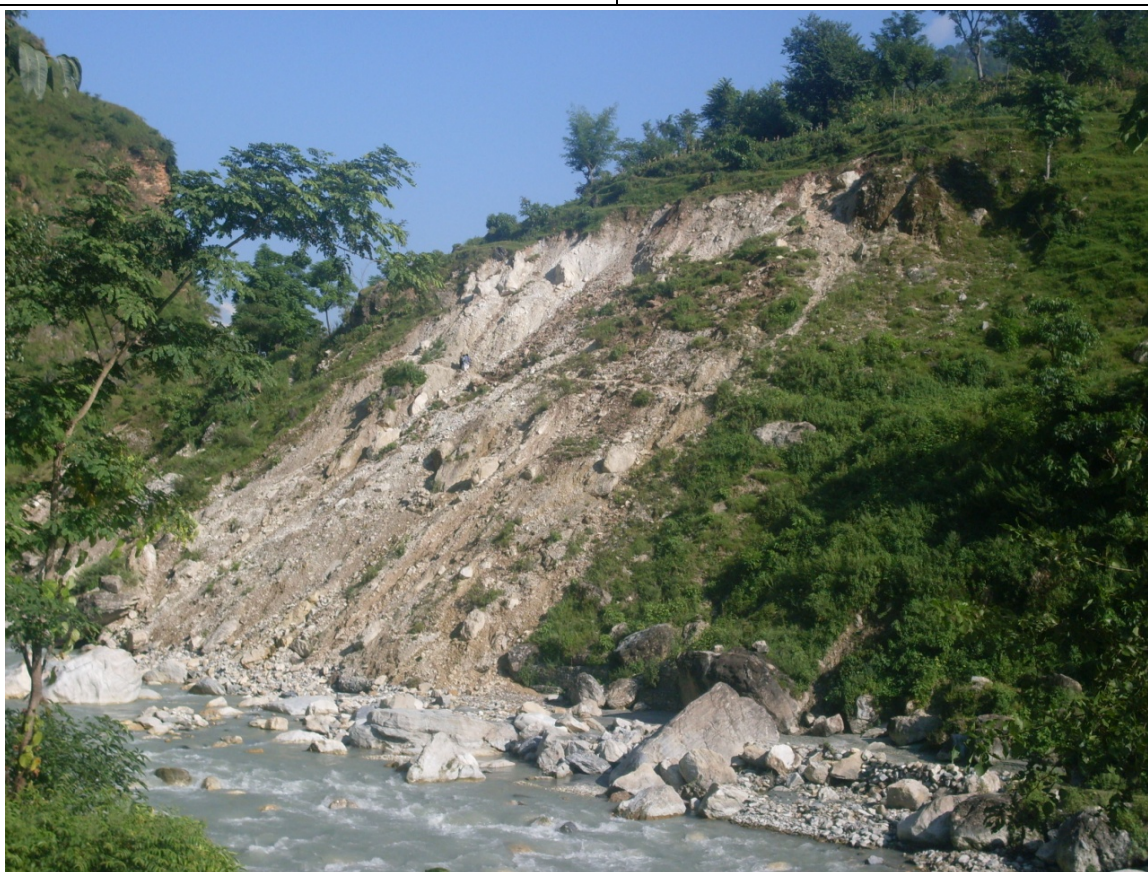
Size (m²)	150 × 200
Geomorphology	Moderate to steep
Geology	Crushed rock masses with large boulders
Formation	Malekhu
Hydrology	Damp
Failure type	Landslide
Scale	Large
Nature	Debris
Dominant mechanism	Loose soil mass, toe cutting
Hazard rating	High

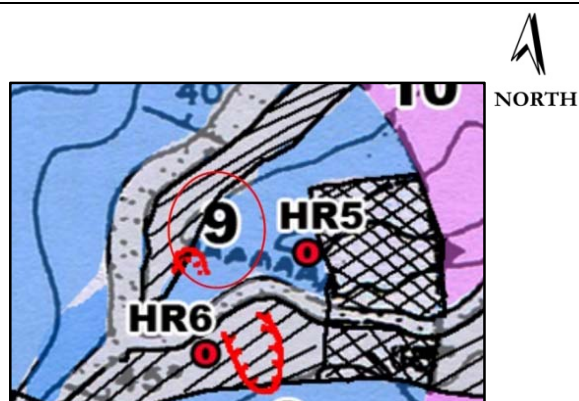
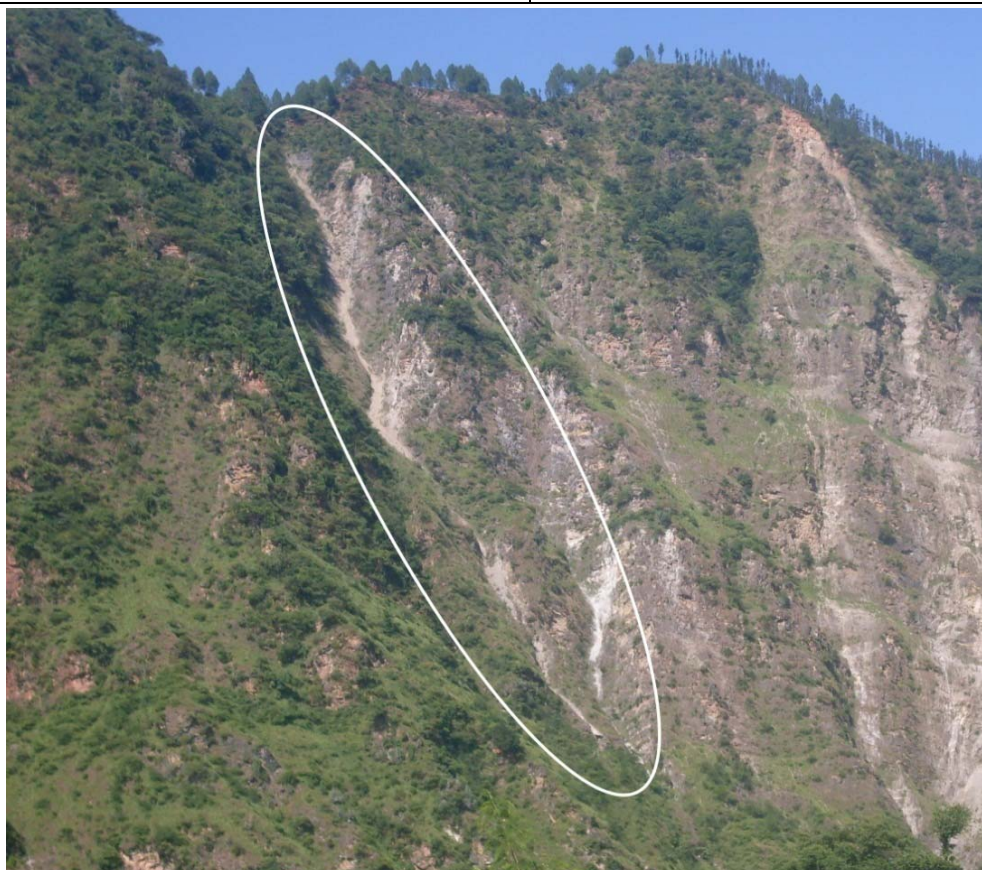
Size (m²)	20 × 30
Geomorphology	Moderate slope
Geology	Colluviums
Formation	Malekhu
Hydrology	Dry
Failure type	Rock fall
Scale	Small
Nature	Rock
Dominant mechanism	Steep slope, highly jointed rock mass
Hazard rating	High

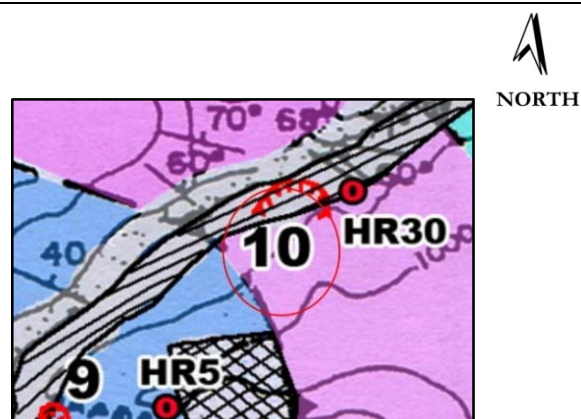
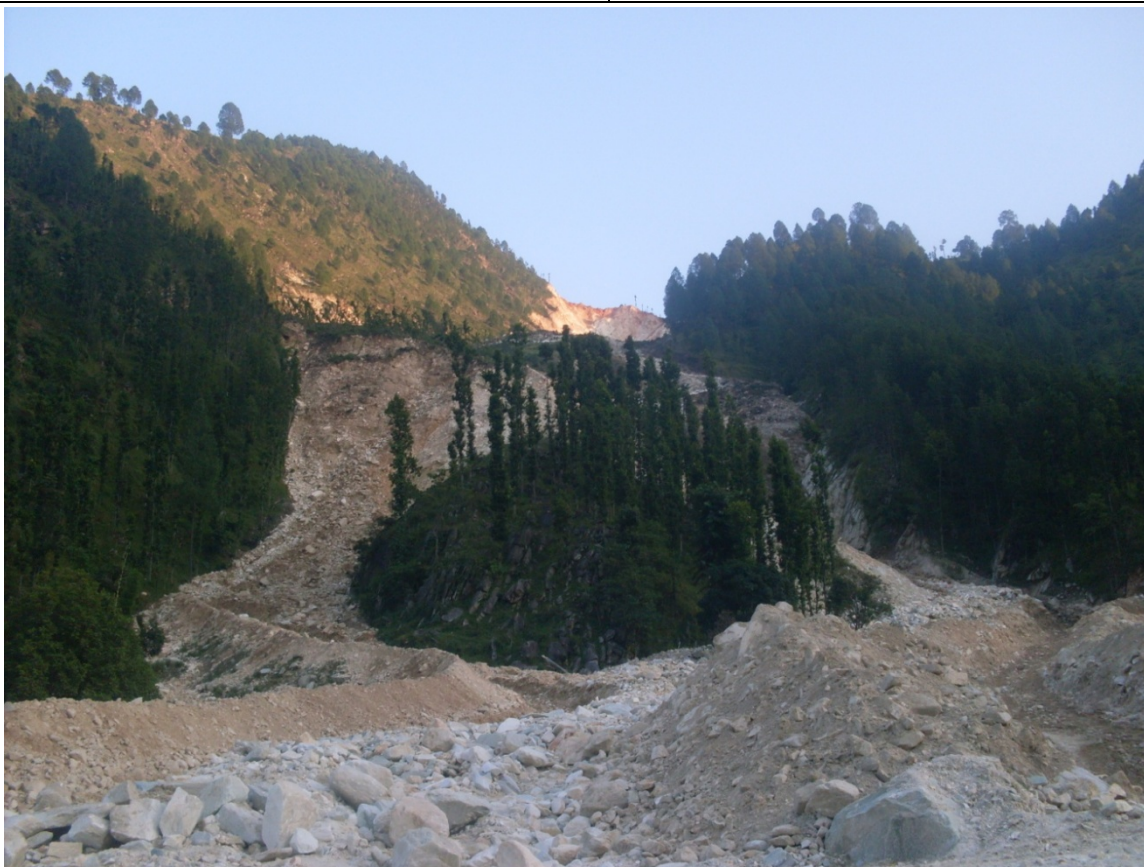
Size (m²)	300 × 600
Geomorphology	Moderate to steep slope
Geology	Highly crushed weak and fragile rock masses
Formation	Banku
Hydrology	Flowing water
Failure type	Debris flow
Scale	Large
Nature	Debris
Dominant mechanism	Crushed rock mass, poor drainage
Hazard rating	High

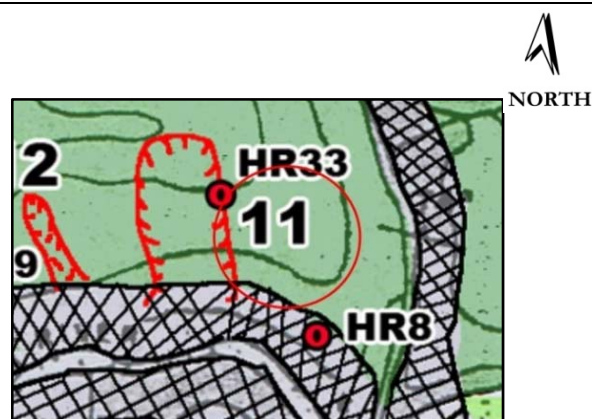
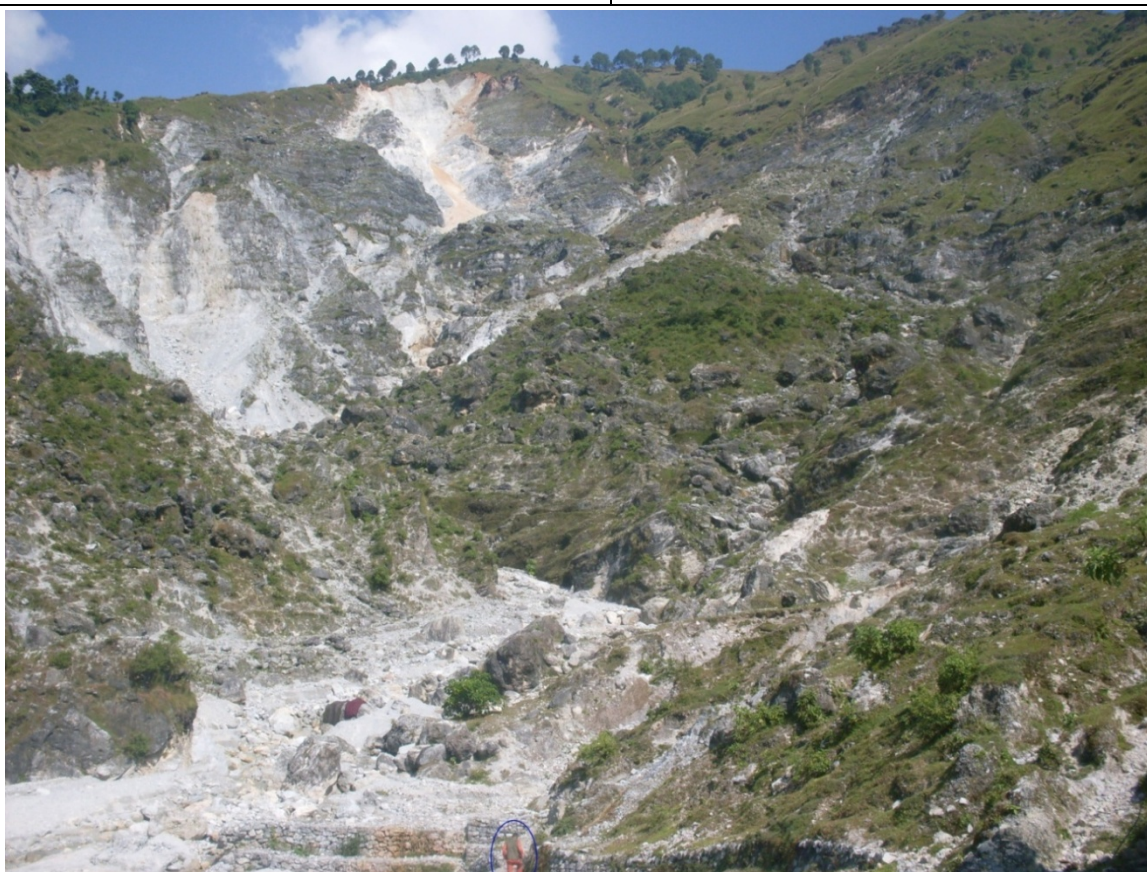
Size (m²)	300 × 300
Geomorphology	Steep slope
Geology	Highly crushed dolomite with phyllite
Formation	Galyang
Hydrology	Dry/ flowing water
Failure type	Collapse
Scale	Large
Nature	Debris
Dominant mechanism	Steep slope, Crushed rock mass and poor drainage
Hazard rating	Very high

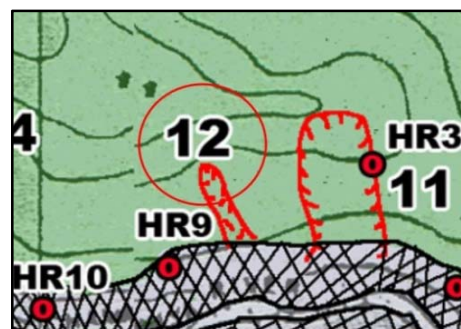
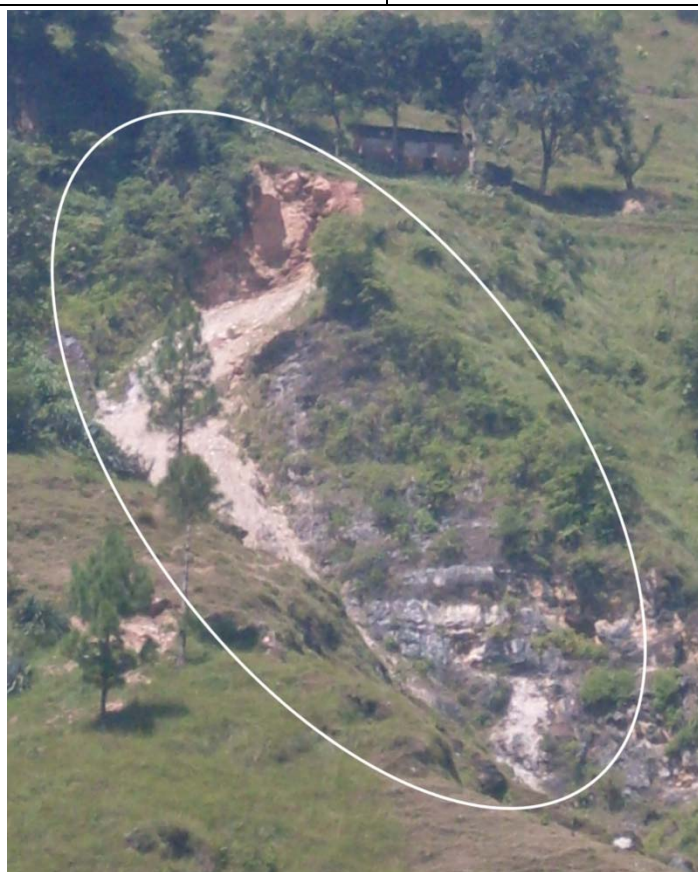
Size (m²)	5 × 40
Geomorphology	Moderate to steep slope
Geology	Loose and fractured rock masses
Formation	Galyang
Hydrology	Dry to damp
Failure type	Landslide
Scale	Small
Nature	Debris
Dominant mechanism	Steep slope, loose colluviums
Hazard rating	Very high

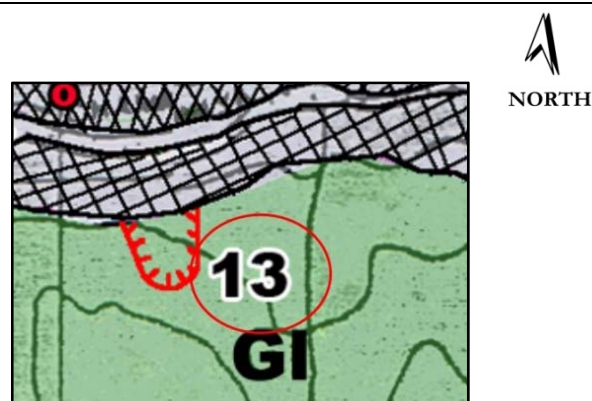
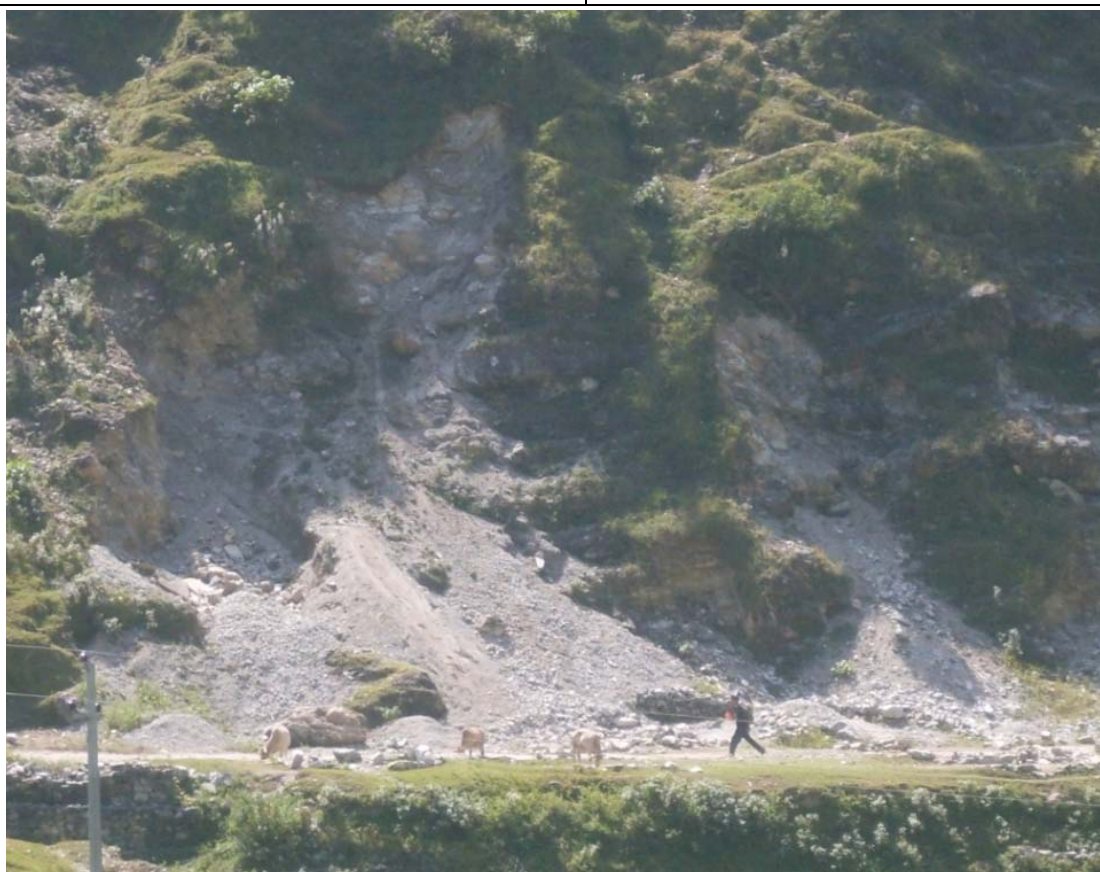
Size (m²)	50 × 20
Geomorphology	Steep to Moderate slope
Geology	Colluvium mixed with alluvium
Formation	Galyang
Hydrology	Damp
Failure type	Collapse
Scale	Small
Nature	Debris
Dominant mechanism	Steep slope, loose colluviums
Hazard rating	Very high

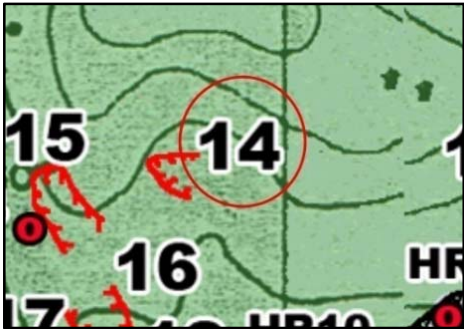
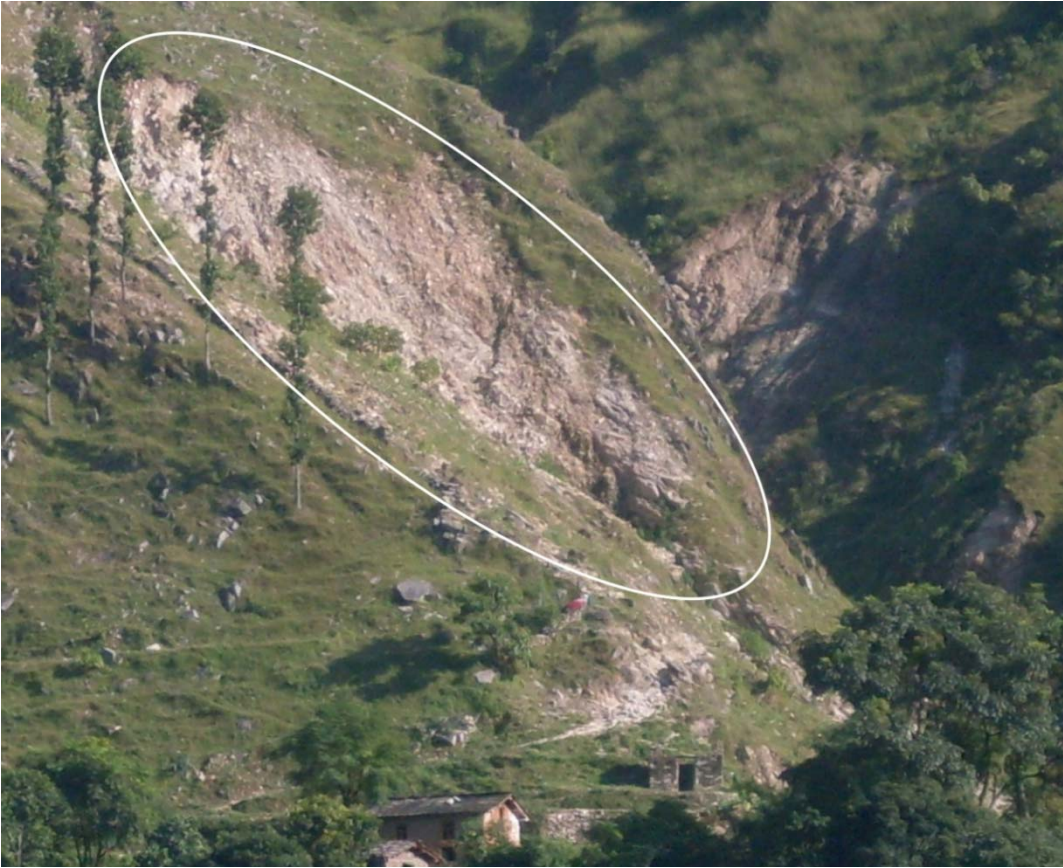
LANDSLIDE 14	
Location	
Right bank of Kuku Khola above Osap	
Easting 0	Northing 0 Elevation 0
Characteristics of slide	
Size (m ²)	25 × 30
Geomorphology	Moderate slope
Geology	Colluviums
Formation	Galyang
Hydrology	Damp
Failure type	Landslide
Scale	Small
Nature	Debris
Dominant mechanism	Steep slope, loose colluviums
Hazard rating	Very high

Proposed stabilization measures	
<ul style="list-style-type: none"> • Gabion wall at toe • Slope modification • Jute netting and grass vegetation

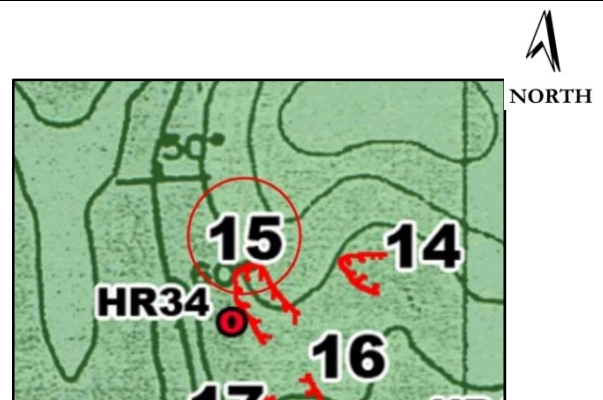
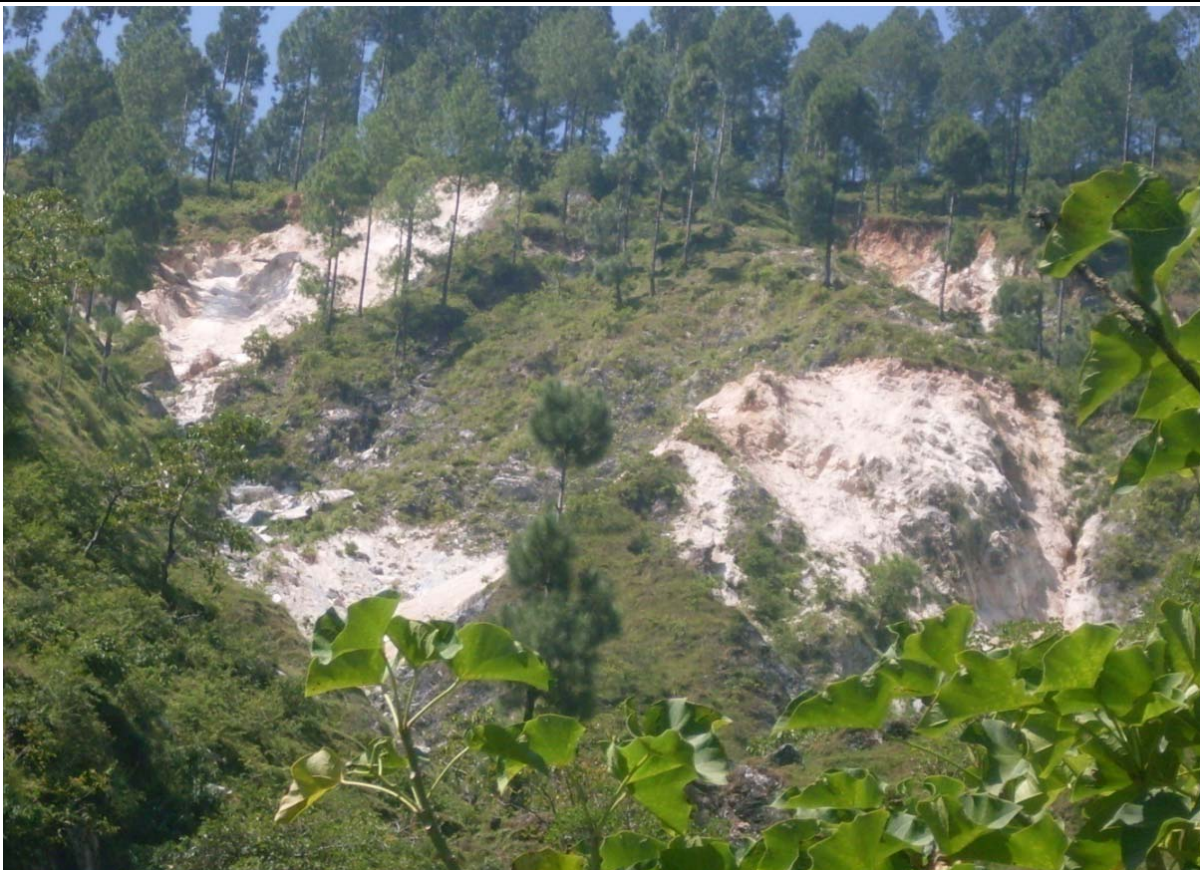
LANDSLIDE 15**Location**

Size (m²)	150 × 300
Geomorphology	Moderate to steep slope
Geology	Highly crushed rock with boulders
Formation	Galyang
Hydrology	Dry
Failure type	Landslide
Scale	Large
Nature	Debris
Dominant mechanism	Steep slope, loose colluviums
Hazard rating	Very high

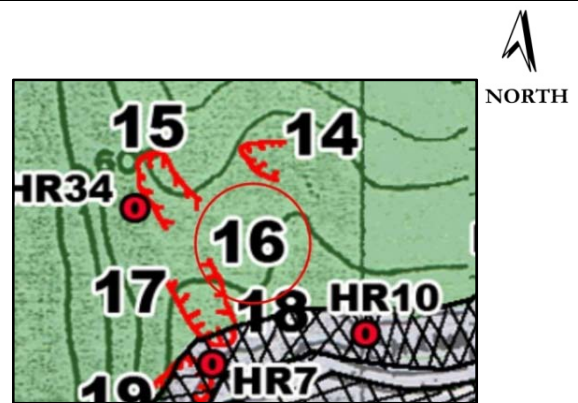
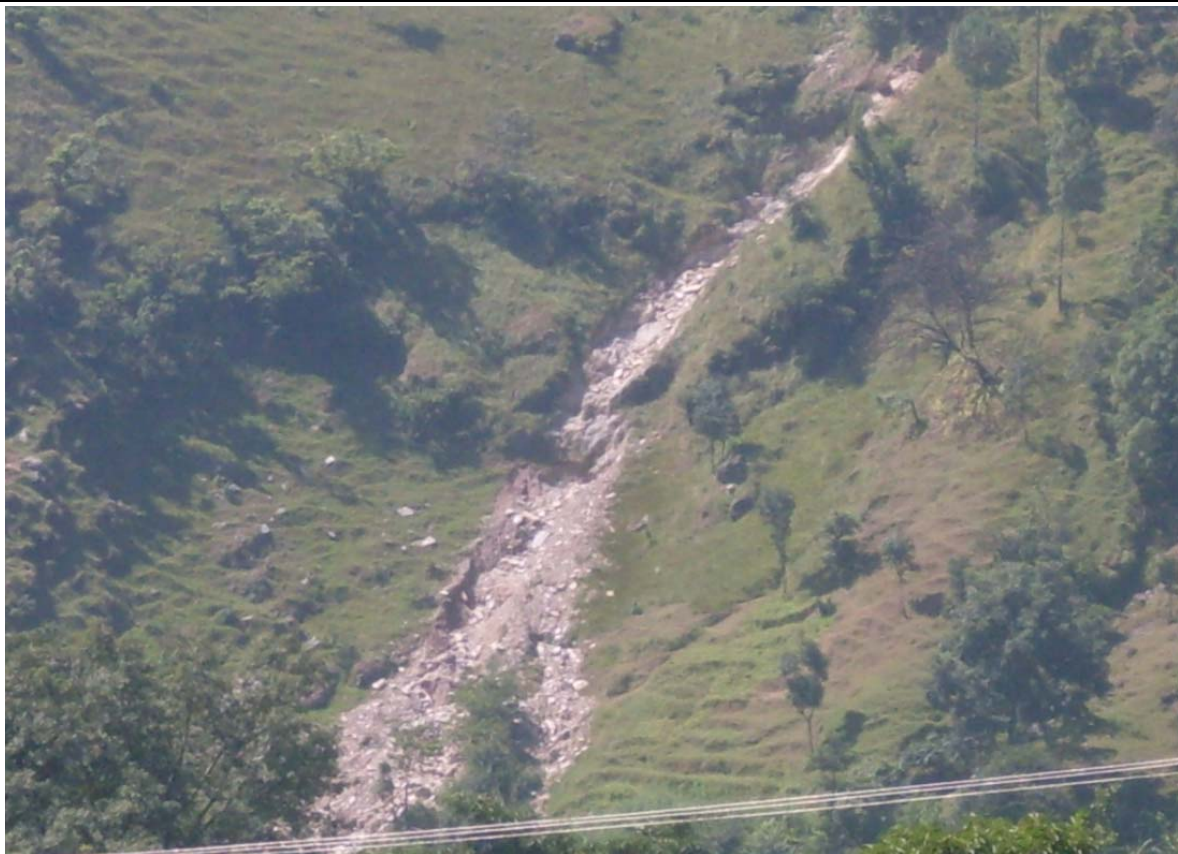
Size (m²)	5 × 50
Geomorphology	Moderate slope
Geology	Phyllite mixed with Colluvium
Formation	Galyang
Hydrology	Dry to damp
Failure type	Landslide
Scale	Small
Nature	Debris
Dominant mechanism	Steep slope, loose colluviums
Hazard rating	Very high

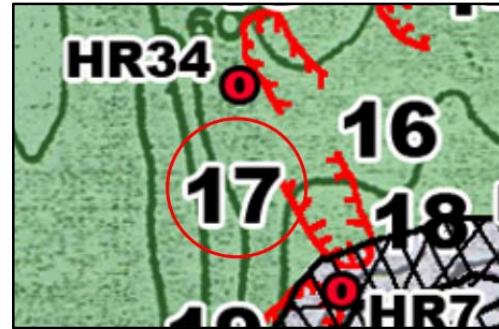
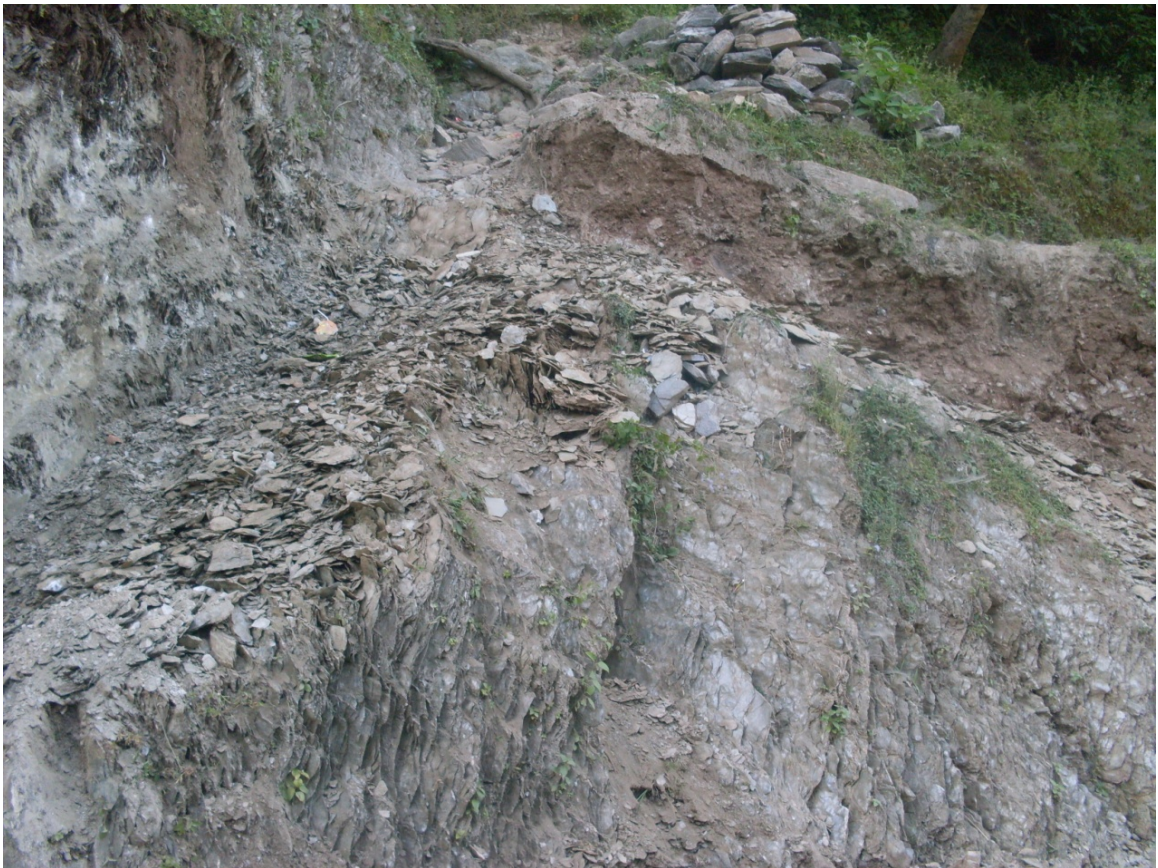
Size (m²)	20 × 30
Geomorphology	Moderate slope
Geology	Loose rock piece
Formation	Galyang
Hydrology	Dry
Failure type	Rock fall
Scale	Small
Nature	Rock
Dominant mechanism	Loose rock mass, road cutting
Hazard rating	Very high

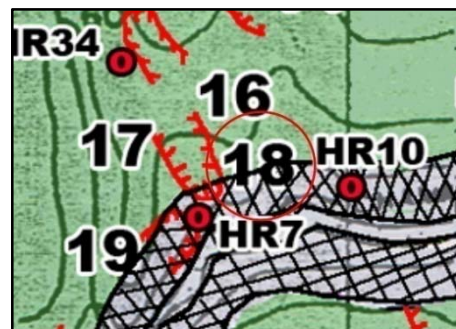
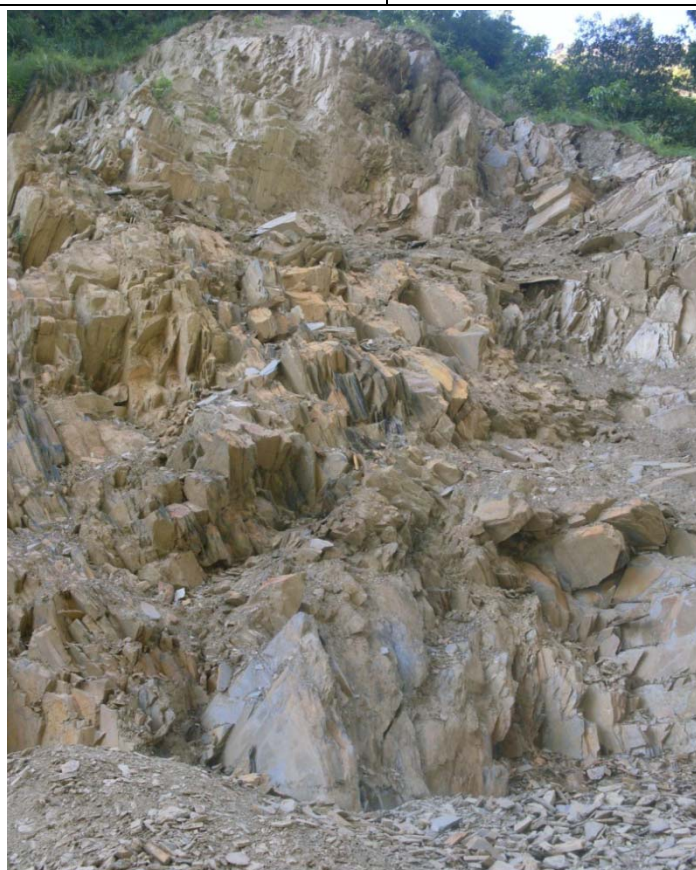
Size (m²)	300 × 150
Geomorphology	Steep slope
Geology	Highly crushed and fractured rock masses
Formation	Galyang
Hydrology	Damp to seepage
Failure type	Rock fall
Scale	Medium
Nature	Rock
Dominant mechanism	Highly jointed rock mass, road cutting
Hazard rating	Very high

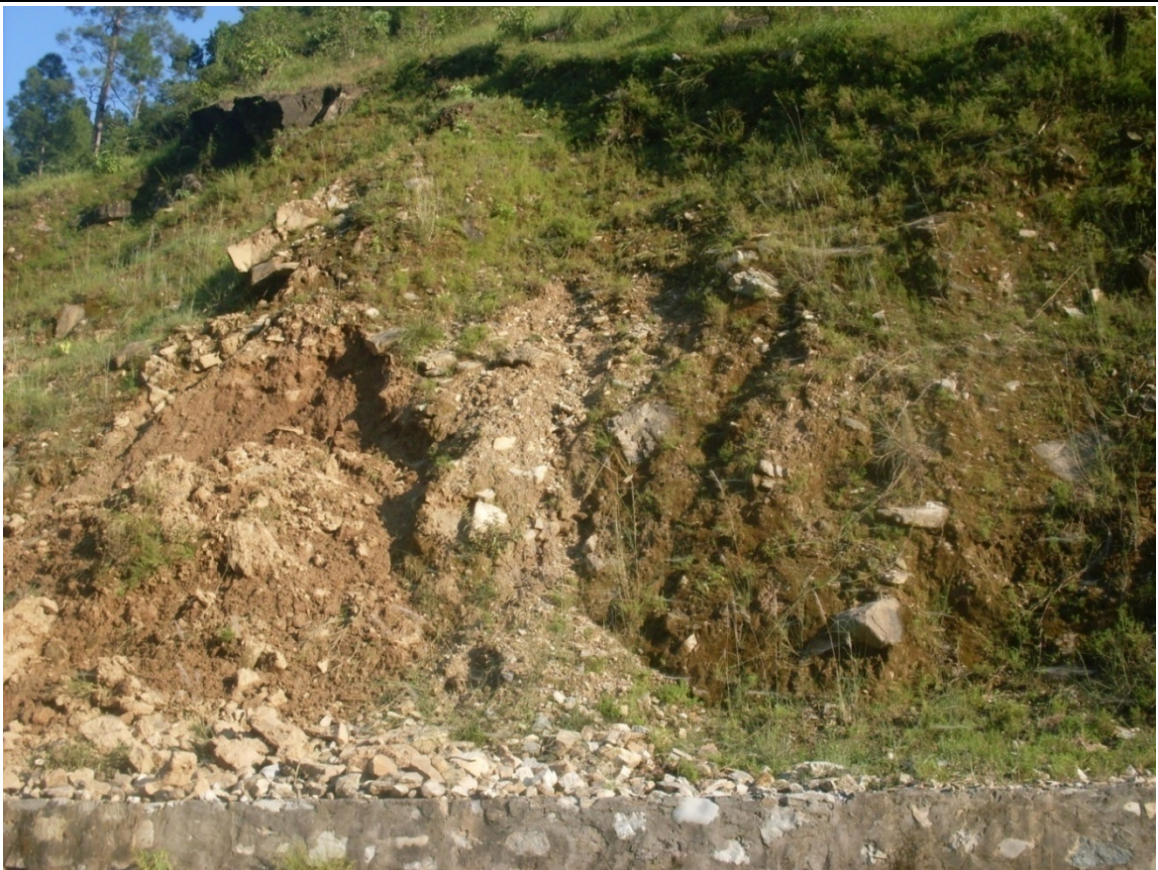
Size (m²)	20 × 10
Geomorphology	Moderate slope
Geology	Colluvial
Formation	Galyang
Hydrology	Damp
Failure type	Collapse
Scale	Small
Nature	Debris
Dominant mechanism	Loose soil mass, road cutting
Hazard rating	Very high
