B. GEOLOGICAL STUDIES

B.2 INVENTORY OF EXISTING LAND INSTABILITIES

LANDSLIDE 1**Location**

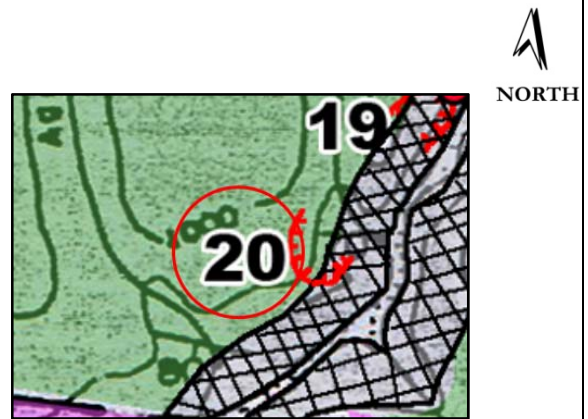
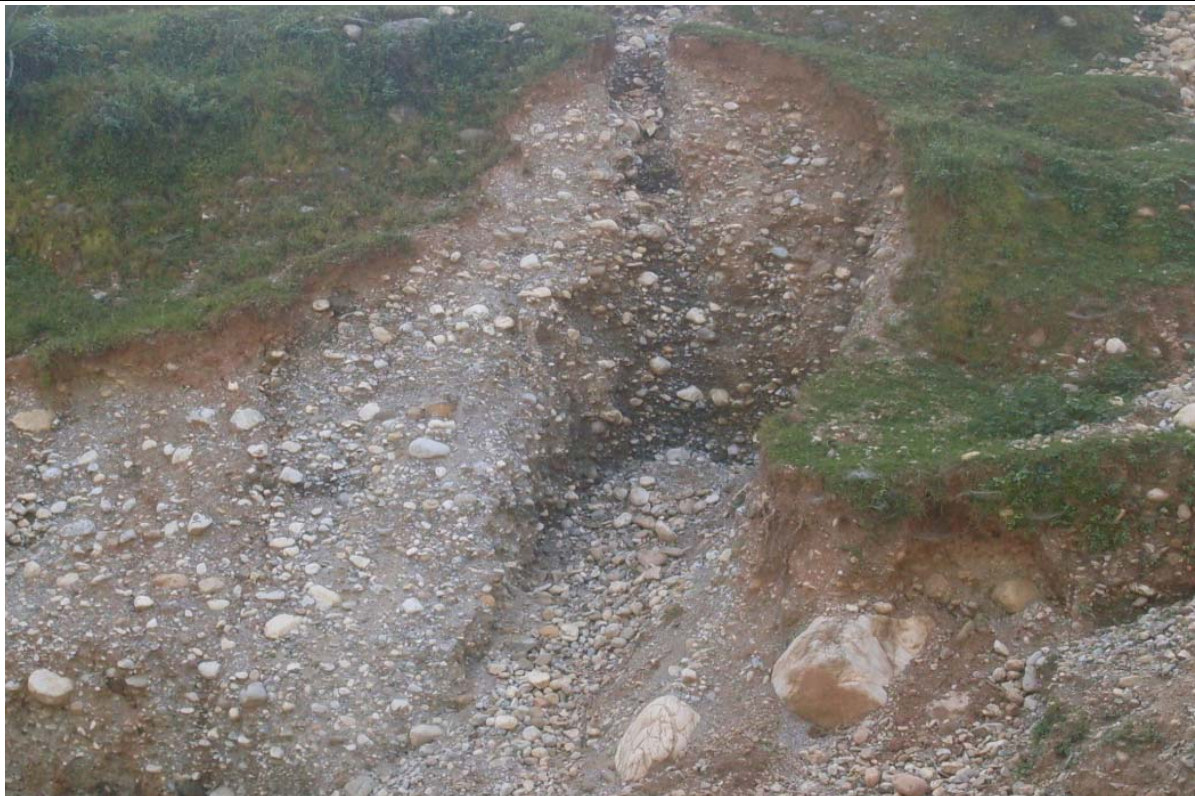
Size (m²)	30 × 15
Geomorphology	Gentle to moderate slope
Geology	Colluvium with alluvium loose masses
Formation	Galyang
Hydrology	Dry to damp
Failure type	Collapse
Scale	Small
Nature	Debris
Dominant mechanism	Loose alluviums, road cutting
Hazard rating	Very high

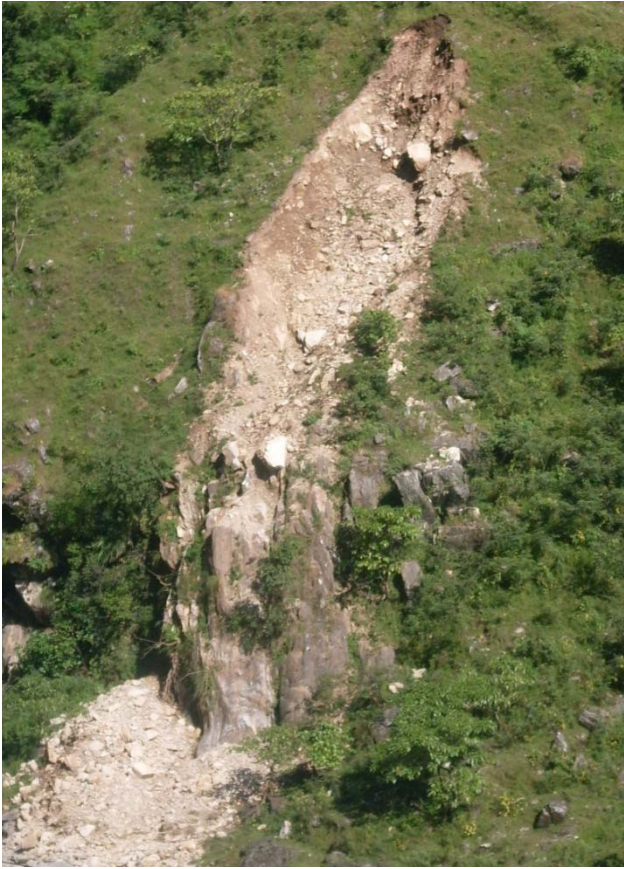
LANDSLIDE 21	
Location	
Left bank of Chameliya River opposite to Agari Gad	
Easting	450734
Northing	3277651
Elevation	750
Characteristics of slide	
Size (m²)	5 × 30
Geomorphology	Steep slope
Geology	Colluvium with Very weak phyllite and quartzite rock
Formation	Kalikot
Hydrology	Dry to damp
Failure type	Collapse
Scale	Small
Nature	Debris
Dominant mechanism	Steep slope, loose soil mass
Hazard rating	Very high

Proposed stabilization measures	
<ul style="list-style-type: none"> • Toe protection • Gabion wall • Slope modification (< 30°) with grass vegetation

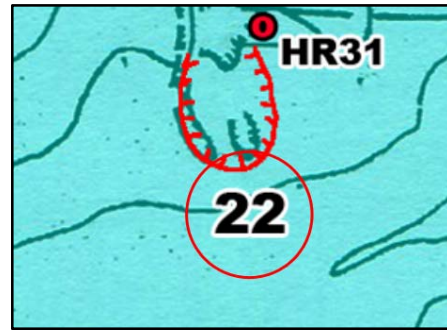
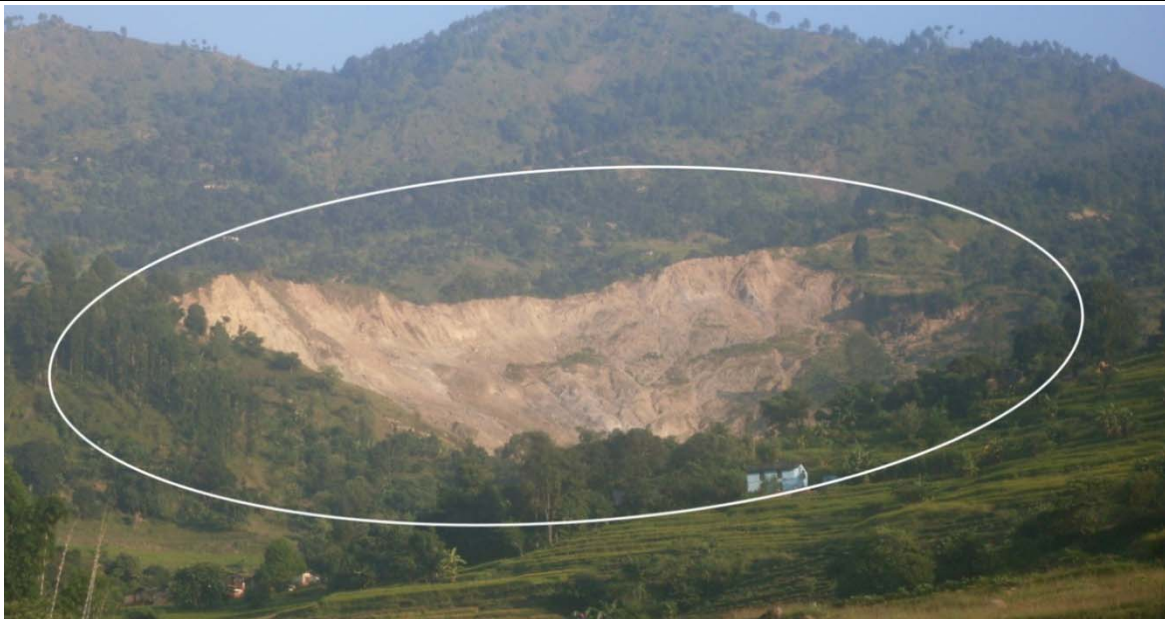
Size (m²)	600 × 500
Geomorphology	Steep slope
Geology	Highly crushed disoriented rock schists/ quartzite
Formation	Kalikot
Hydrology	Flowing water
Failure type	Collapse
Scale	Large
Nature	Debris
Dominant mechanism	Crushed rock , loose soil mass, poor drainage
Hazard rating	High

- Shotcreting with wire mesh at crown
- Gabion wall
- Water management
- Filling of cracks at crown
- Modification of steep slope (< 30°)
- Jute netting and grass vegetation

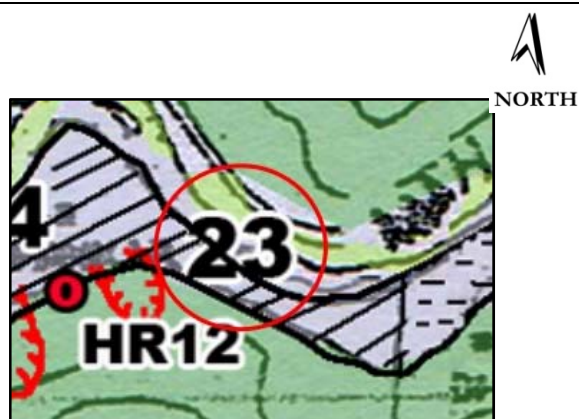
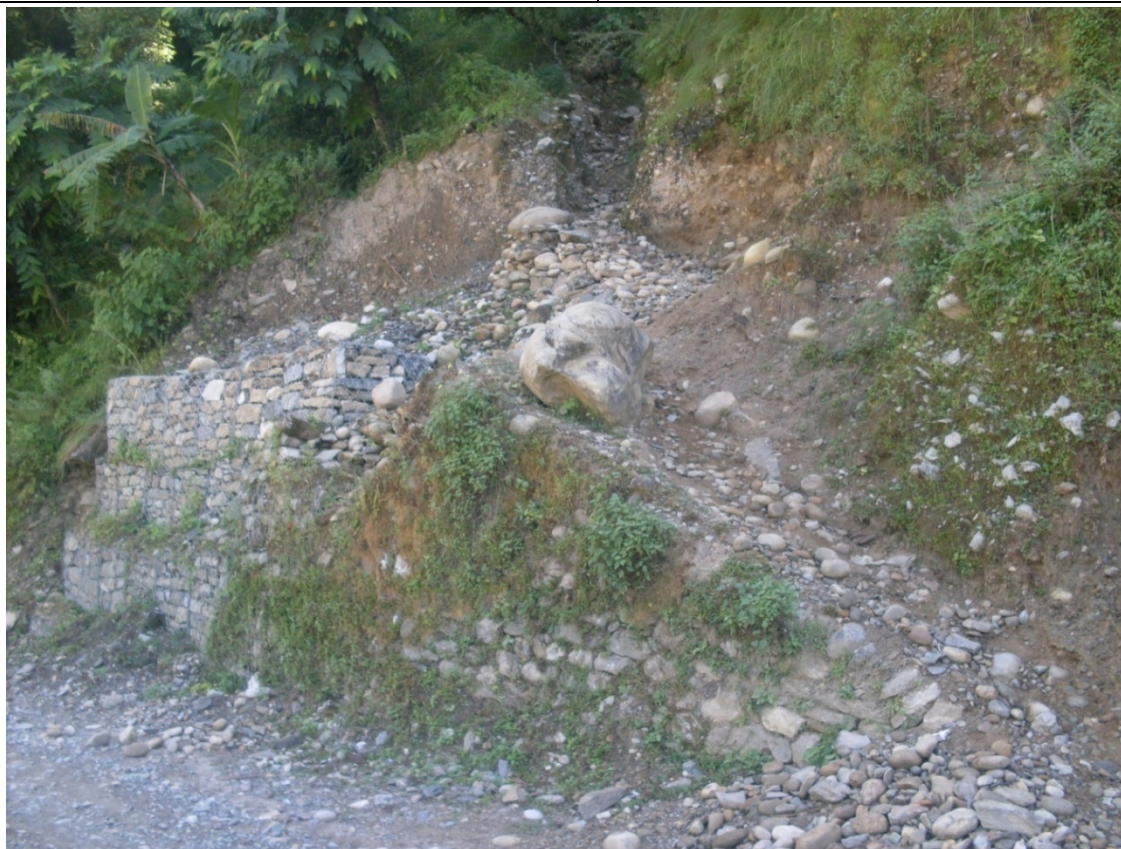
Size (m²)	15 × 7
Geomorphology	Moderate slope
Geology	Alluvium, loose gravels with sands and clays
Formation	Galyang
Hydrology	Wet
Failure type	Collapse
Scale	Small
Nature	Debris
Dominant mechanism	Loose alluvium, road cutting, poor drainage
Hazard rating	High

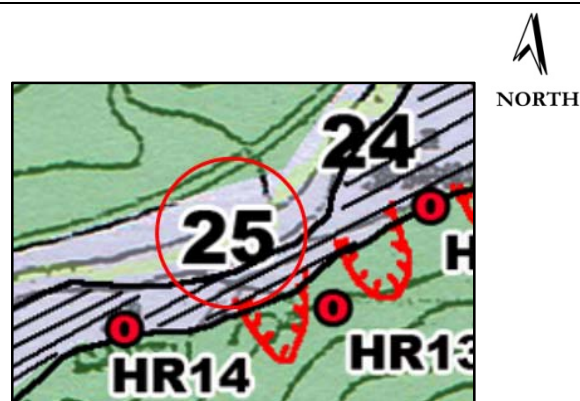
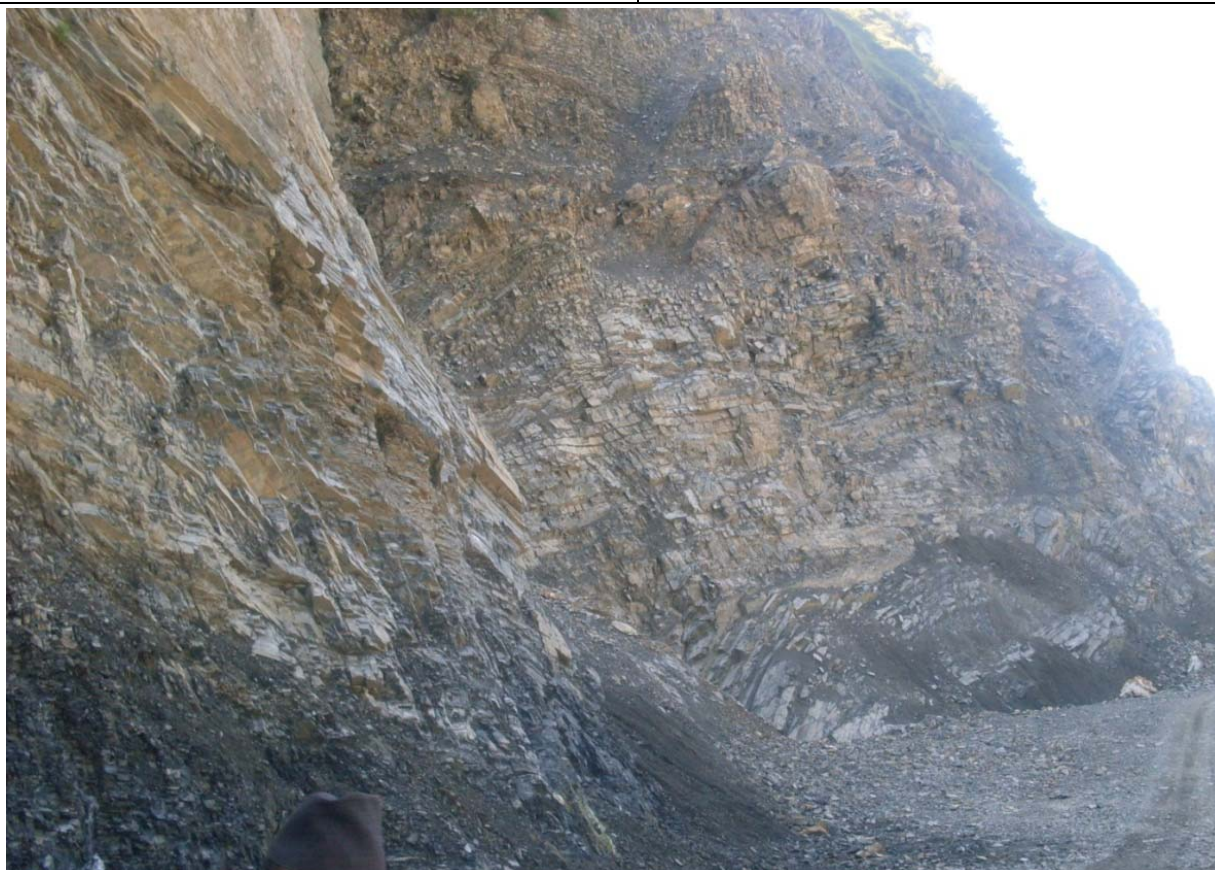
Size (m²)	250 × 50
Geomorphology	Moderate to steep slope
Geology	Dolomite with slate rock masses
Formation	Galyang
Hydrology	Dry to wet
Failure type	Rock fall
Scale	Medium
Nature	Rock
Dominant mechanism	Steep slope, highly crushed rock, road cutting
Hazard rating	High

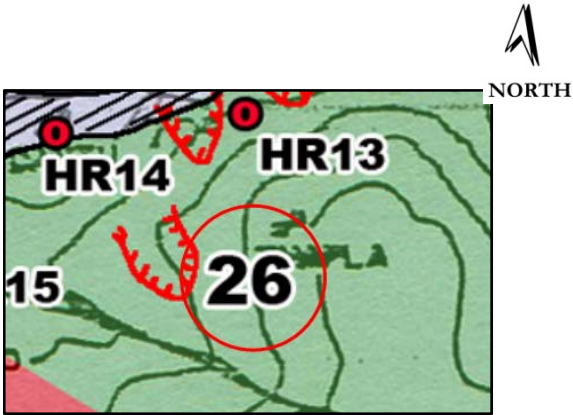
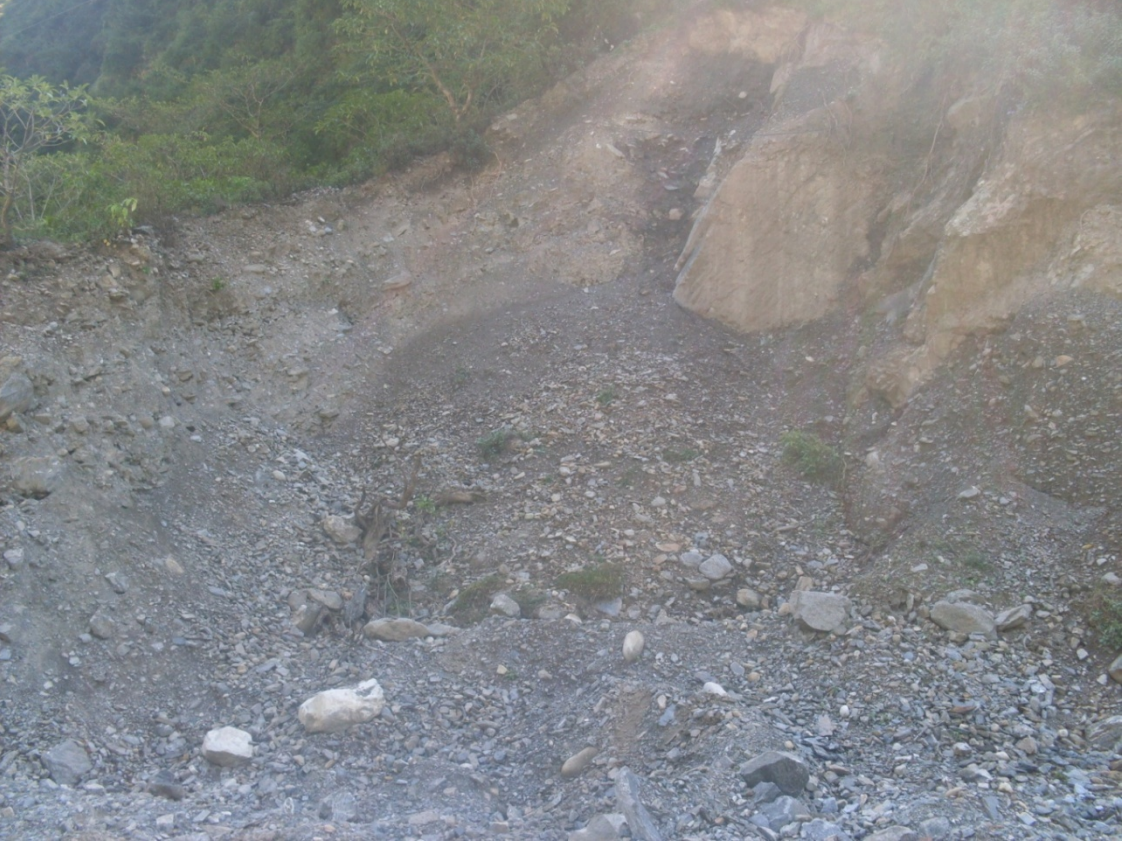
LANDSLIDE 26	
Location	
Left bank of Mahakali at Dattu	
Easting	444729
Northing	3297114
Elevation	701
Characteristics of slide	
Size (m²)	25 × 60
Geomorphology	Steep slope
Geology	Colluvium angular rock fragments with silt sand and clays
Formation	Galyang
Hydrology	Wet
Failure type	Collapse
Scale	Small
Nature	Debris
Dominant mechanism	Loose colluviums, poor drainage, road cutting
Hazard rating	High

Proposed stabilization measures	
<ul style="list-style-type: none"> • Effective drainage system • Gabion wall at Toe • Grass vegetation with jute netting

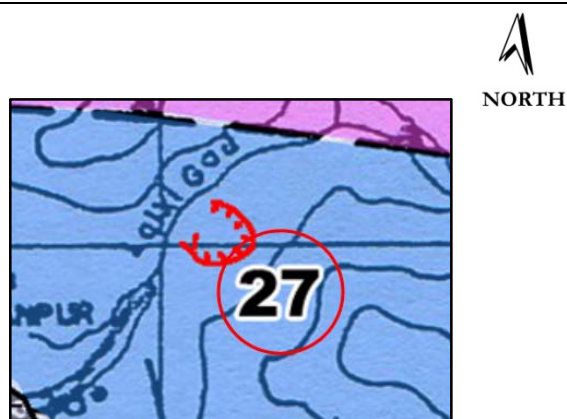
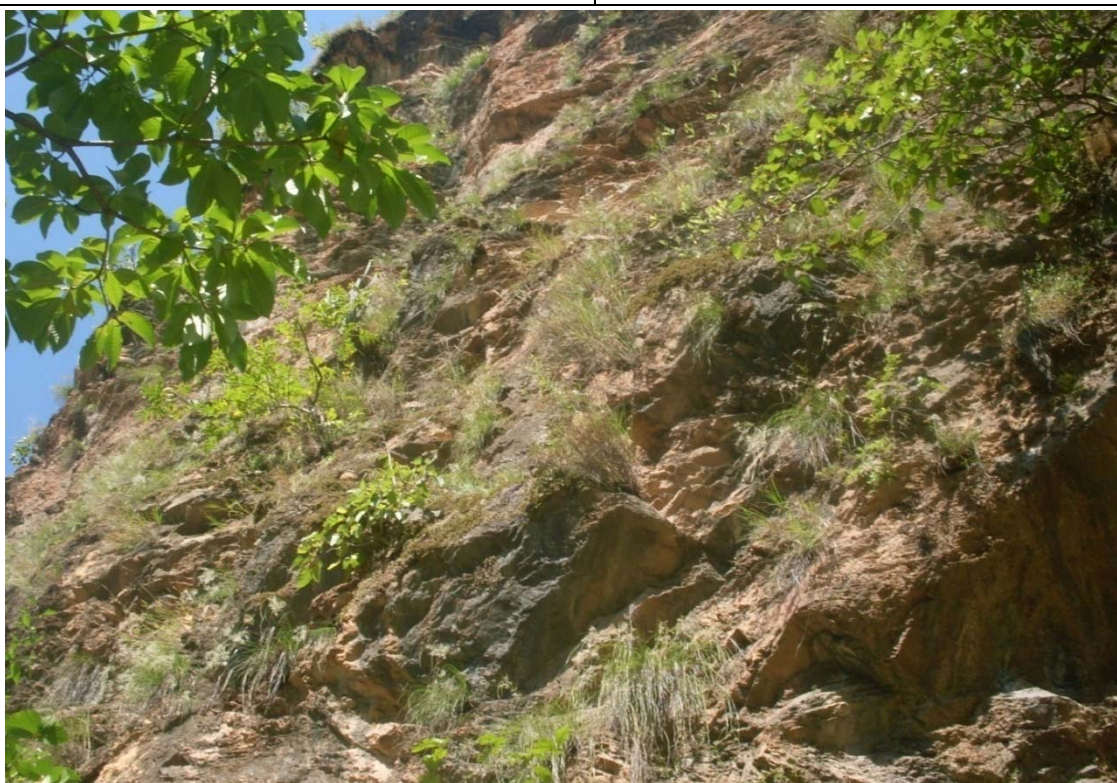
Size (m²)	200 × 100
Geomorphology	Moderate to steep slope
Geology	Highly jointed and fractured rock mass (Dolomites)
Formation	Malekhu
Hydrology	Dry
Failure type	Rock fall
Scale	Large
Nature	Rock
Dominant mechanism	Steep slope, highly jointed rock mass
Hazard rating	Medium

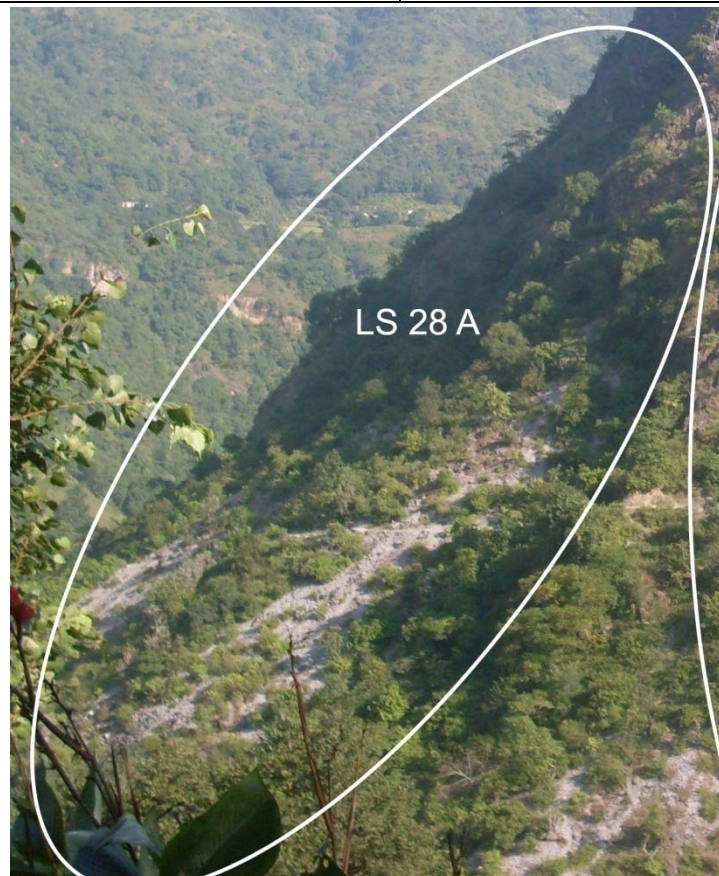
Size (m²)	150 × 150
Geomorphology	Steep slope, cliff
Geology	Massive dolomite, highly fractured and jointed
Formation	Lakharpata
Hydrology	Dry
Failure type	Rock fall
Scale	Large
Nature	Rock
Dominant mechanism	Crushed highly jointed rock mass
Hazard rating	High

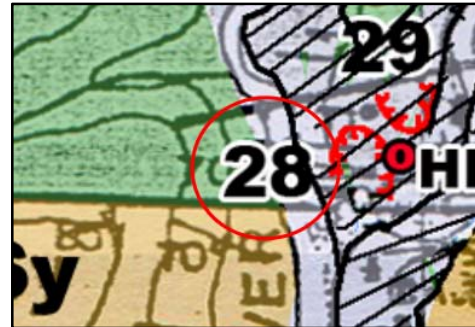
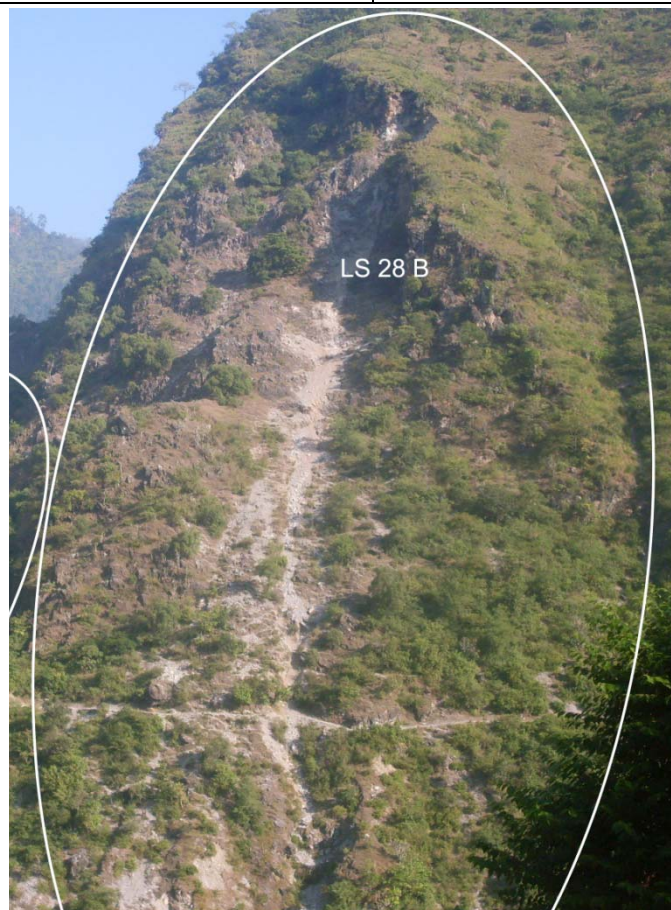
Size (m²)	200 × 100
Geomorphology	Moderate to steep slope
Geology	Loose crushed rocks
Formation	Lakharpata
Hydrology	Dry
Failure type	Rock fall
Scale	Large
Nature	Rock
Dominant mechanism	Crushed highly jointed rock mass
Hazard rating	High

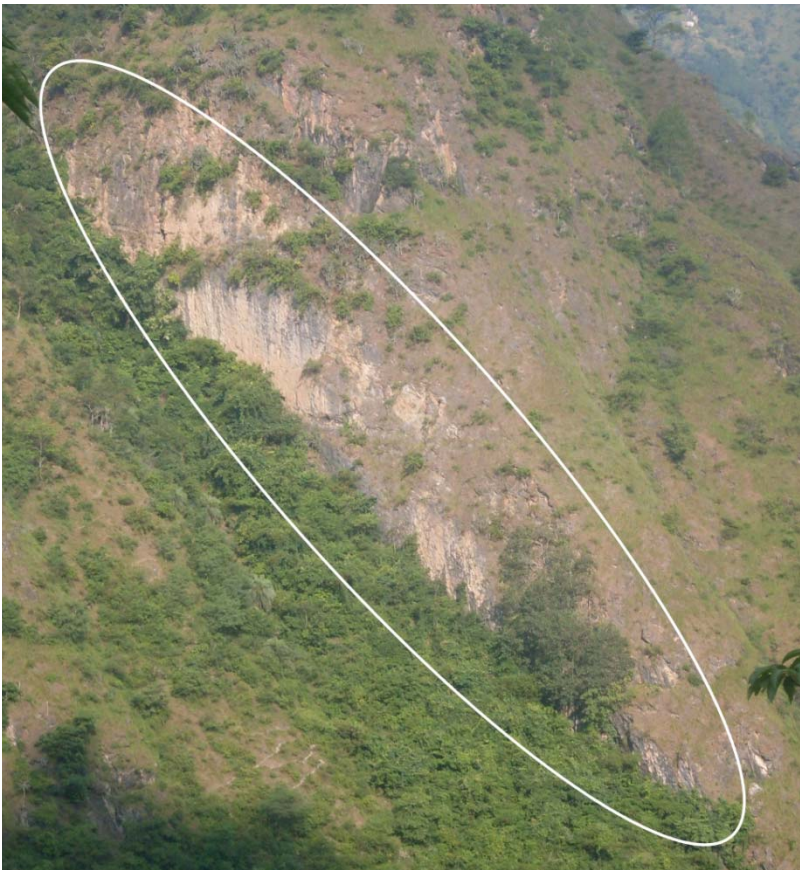
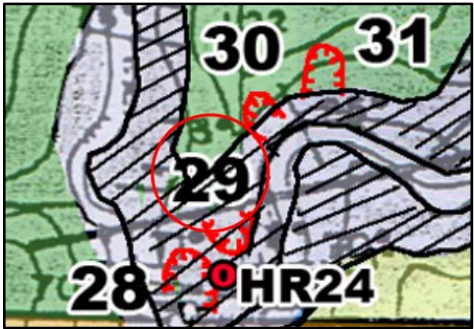
LANDSLIDE 29	
Location	
Landslide at right bank of Chameliya River above Chameliya suspension bridge	
Easting	0
Northing	0
Elevation	0
Characteristics of slide	
Size (m²)	20 × 100
Geomorphology	Steep slope
Geology	Highly jointed dolomite
Formation	Lakharpata
Hydrology	Dry to damp
Failure type	Rock mass failure
Scale	Medium
Nature	Rock
Dominant mechanism	Highly crushed jointed rock mass
Hazard rating	High

Proposed stabilization measures	
<ul style="list-style-type: none"> • Dormant slide • Cross check dam • Vegetated stone pitching in channel

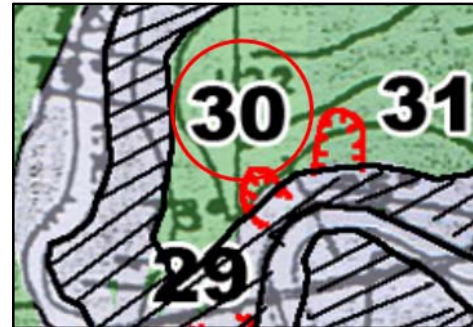
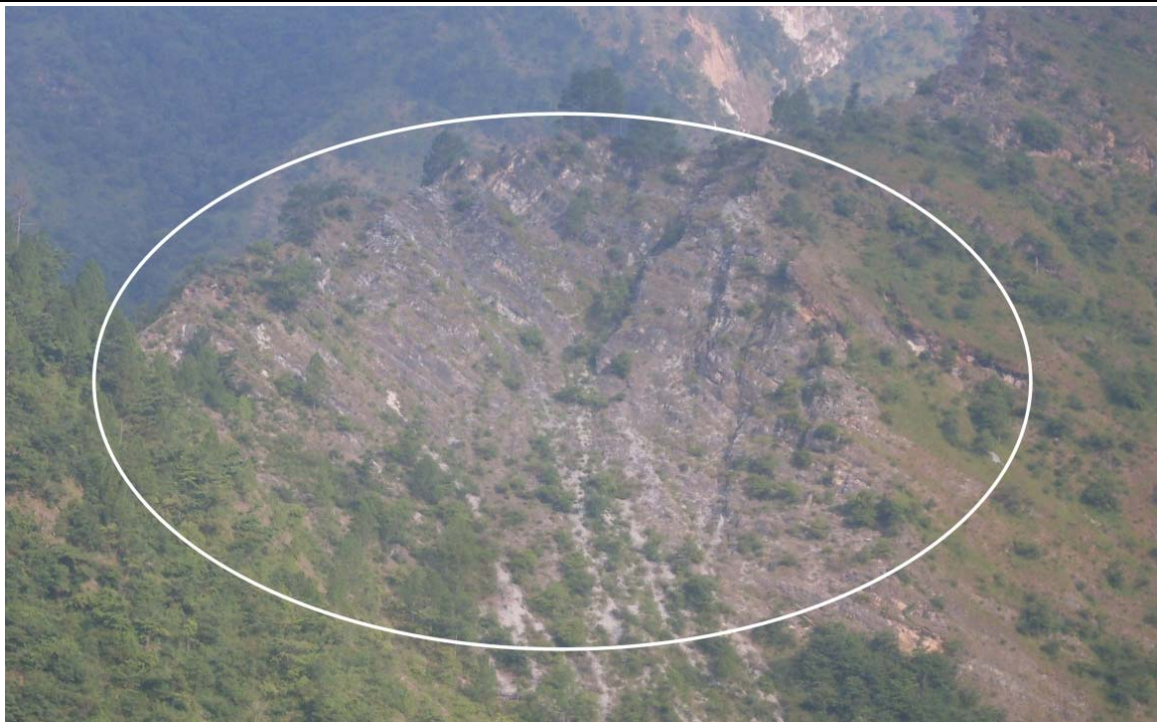
Size (m ²)	20 × 50
Geomorphology	Steep slope
Geology	Highly jointed dolomite
Formation	Lakharpata
Hydrology	Dry to damp
Failure type	Plane failure
Scale	Small
Nature	Rock
Dominant mechanism	Highly crushed jointed rock mass
Hazard rating	High

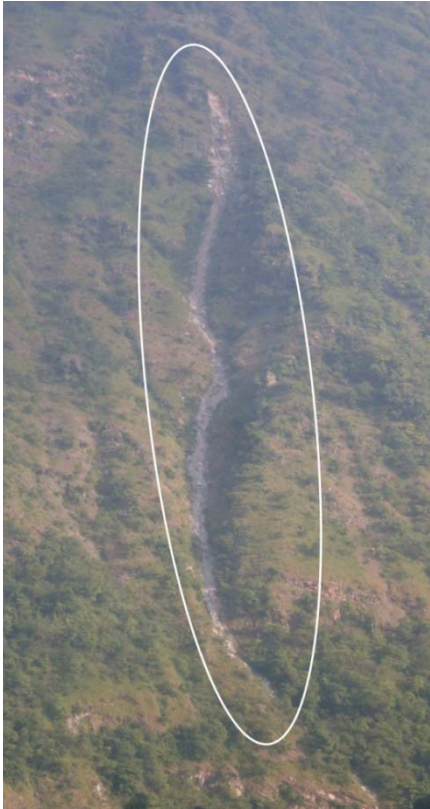
LANDSLIDE 31	
Location	
Landslide at right bank of Chameliya River above Chameliya suspension bridge	
Easting	0
Northing	0
Elevation	0
Characteristics of slide	
Size (m²)	100 × 3
Geomorphology	Steep slope
Geology	Highly jointed dolomite
Formation	Lakharpata
Hydrology	Dry to damp
Failure type	Landslide
Scale	Small
Nature	Rock
Dominant mechanism	Highly crushed jointed rock mass
Hazard rating	High

Proposed stabilization measures	
<ul style="list-style-type: none"> • Dormant slide • Cross check dam • Vegetated stone pitching in channel

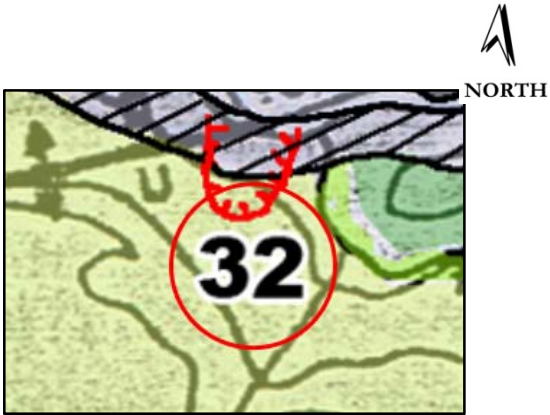
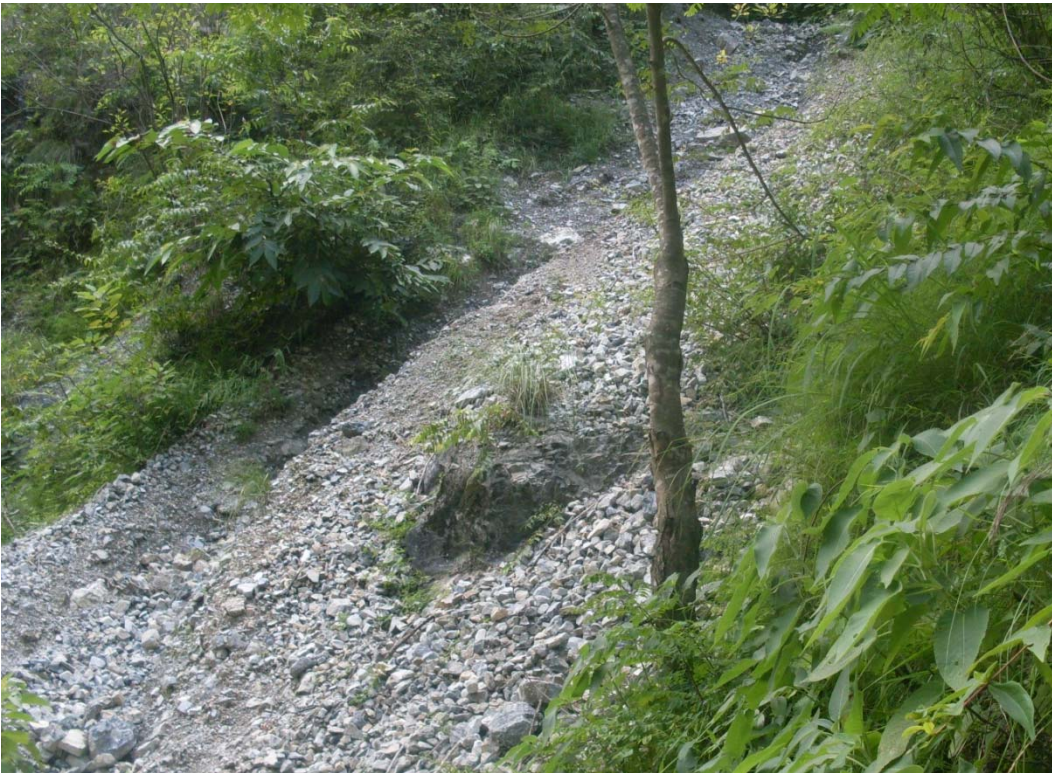
LANDSLIDE 32	
Location	
At confluence of Dhik Gad and Chameliya River	
Easting	448596
Northing	3277469
Elevation	605
Characteristics of slide	
Size (m²)	50 × 50
Geomorphology	Steep slope
Geology	Colluvium, mainly rock pieces, old nearly stabilized
Formation	Lakharpata
Hydrology	Dry to damp
Failure type	Rock fall
Scale	Small
Nature	Rock
Dominant mechanism	Highly crushed loose rock mass
Hazard rating	High

Proposed stabilization measures	
<ul style="list-style-type: none"> • Slope modification • Gabion wall at bottom and brush layering • Water flow management

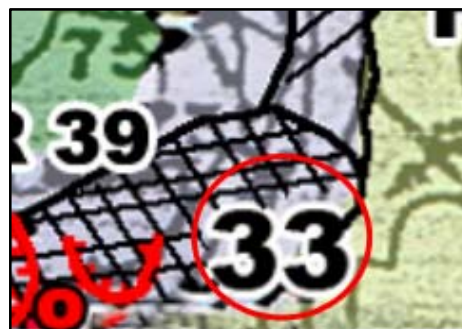
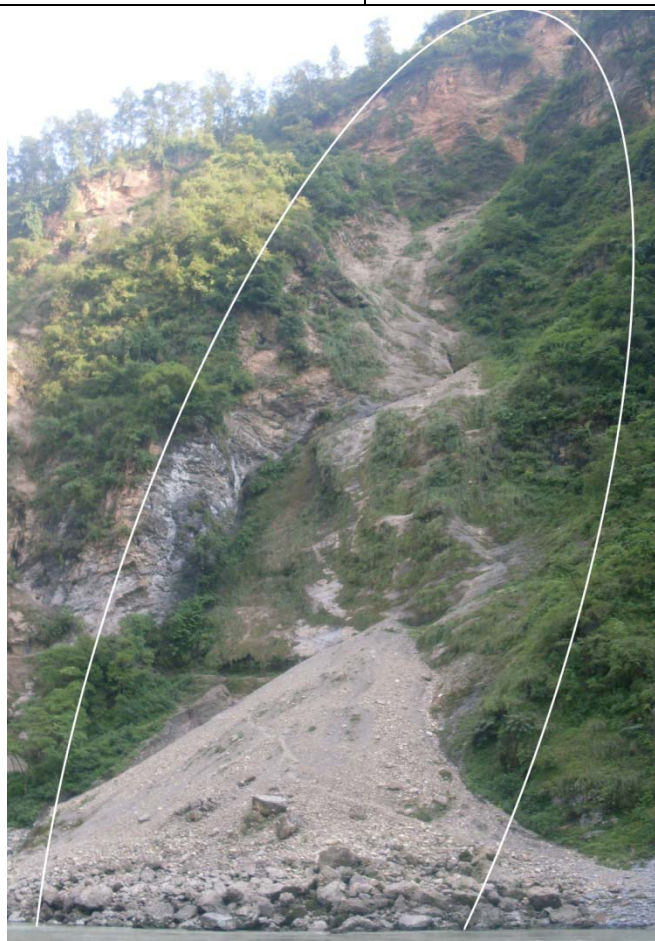
Size (m²)	150 × 25
Geomorphology	Moderate to steep slope
Geology	Highly crushed rock in loose condition
Formation	Lakharpata
Hydrology	Dry to damp
Failure type	Rock fall
Scale	Medium
Nature	Rock
Dominant mechanism	Steep slope, highly jointed crushed rock mass
Hazard rating	Very high

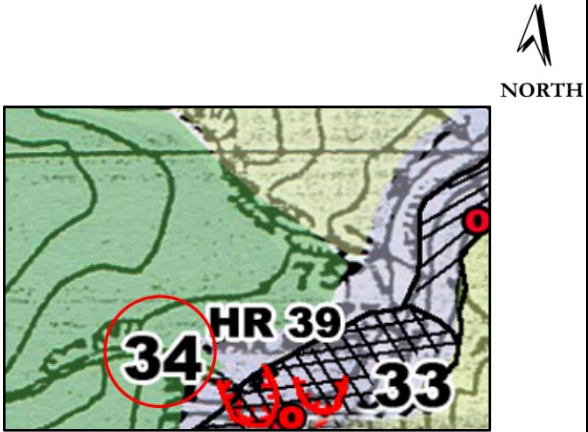
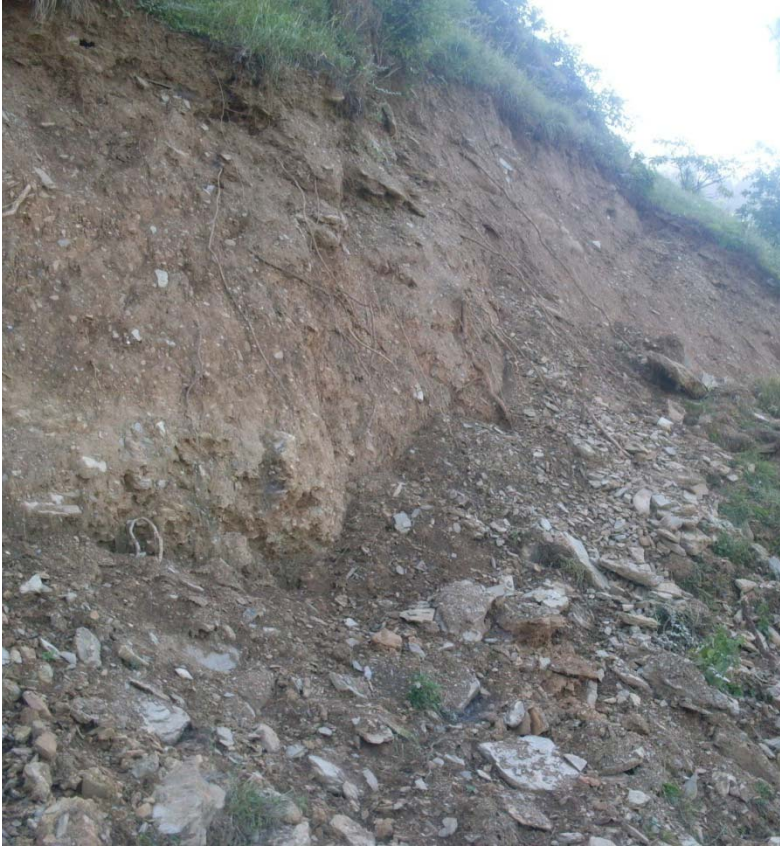
LANDSLIDE 34	
Location	
Left bank of Mahakali River at Jhulaghat	
Easting	440186
Northing	3272099
Elevation	574
Characteristics of slide	
Size (m²)	30 × 30
Geomorphology	Moderate slope
Geology	Colluvium deposits, nearly highly crushed phyllite slates thinly bedded
Formation	Galyang
Hydrology	Dry to damp
Failure type	Collapse
Scale	Small
Nature	Debris
Dominant mechanism	Loose colluviums, road cutting
Hazard rating	Very high

Proposed stabilization measures	
<ul style="list-style-type: none"> • Modification of the slope (< 30°) • Gabion wall at Toe • Grass plantation with jute netting

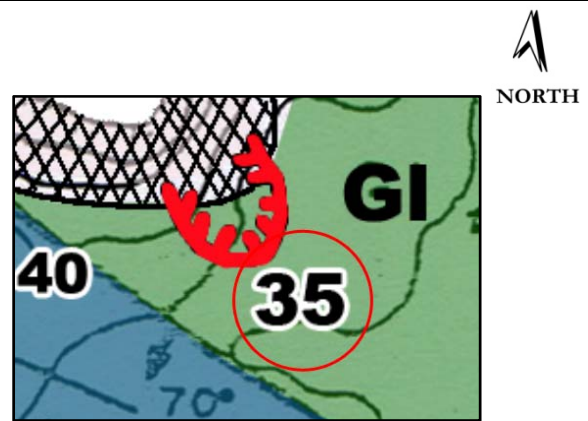
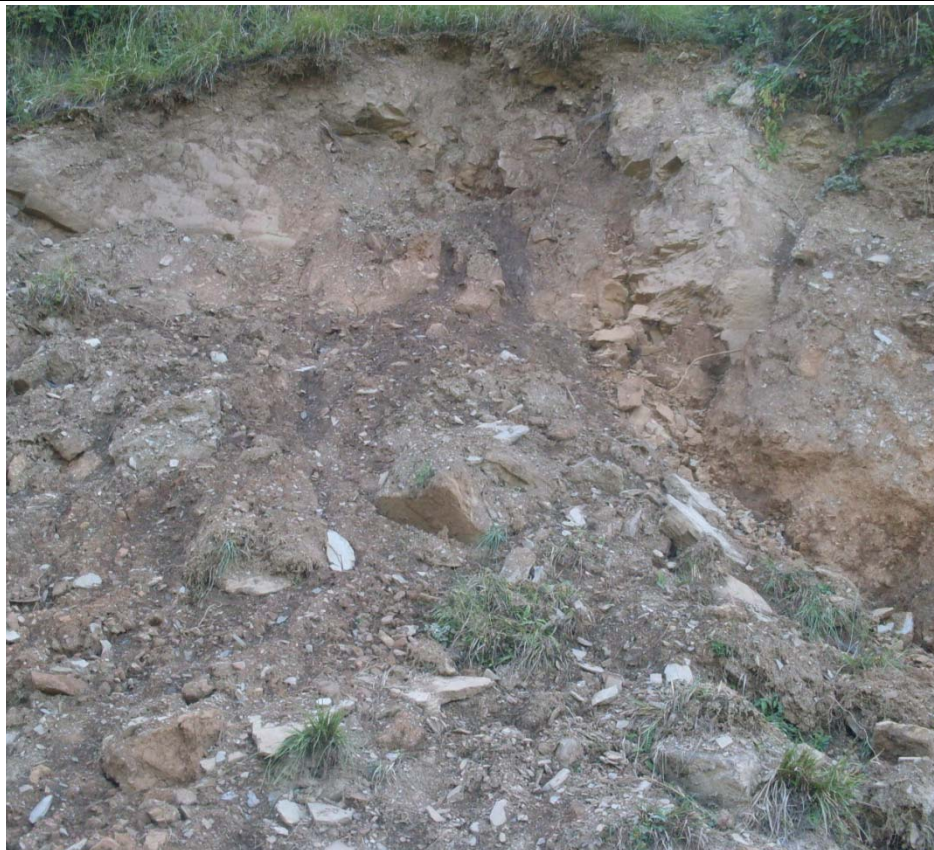
Size (m²)	15 × 50
Geomorphology	Gentle to moderate slope
Geology	Colluvium, rock pieces in silt sandy matrix
Formation	Galyang
Hydrology	Dry to damp
Failure type	Collapse
Scale	Small
Nature	Debris
Dominant mechanism	Loose colluviums, road cutting
Hazard rating	Very high
